U.S. CHEMICAL SAFETY AND HAZARD INVESTIGATION BOARD

INVESTIGATION REPORT

T2 LABORATORIES, INC. RUNAWAY REACTION (Four Killed, 32 Injured)

REPORT NO. 2008-3-I-FL

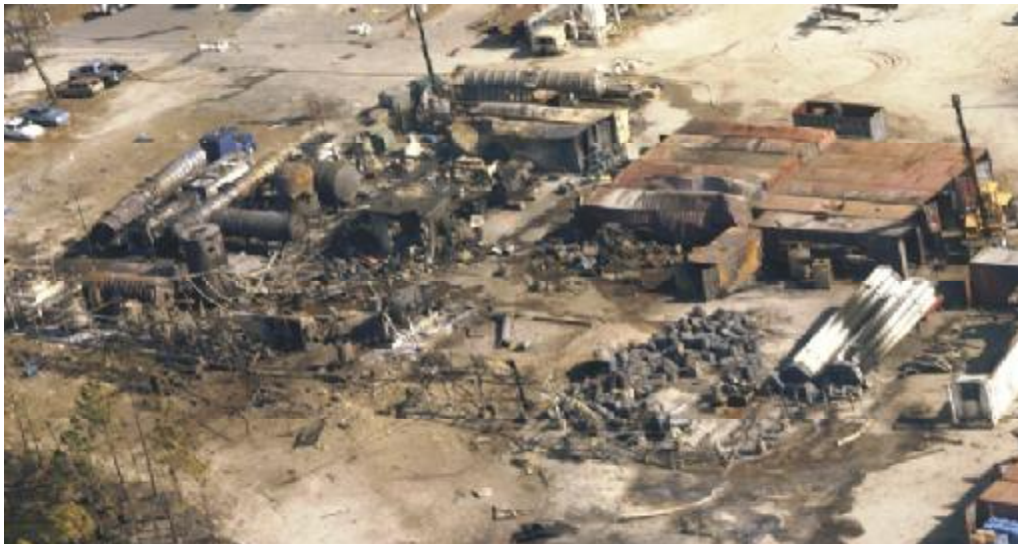
Figure 1. Aerial photograph of T2 taken December 20, 2007.

Debris from the explosion was found up to one mile away, and the blast damaged buildings within one quarter mile of the facility. The City of Jacksonville subsequently condemned buildings used by four of the businesses surrounding T2. Three of these businesses relocated operations while their buildings were repaired; the remaining business, a trucking company adjacent to T2, permanently closed due to lost business.

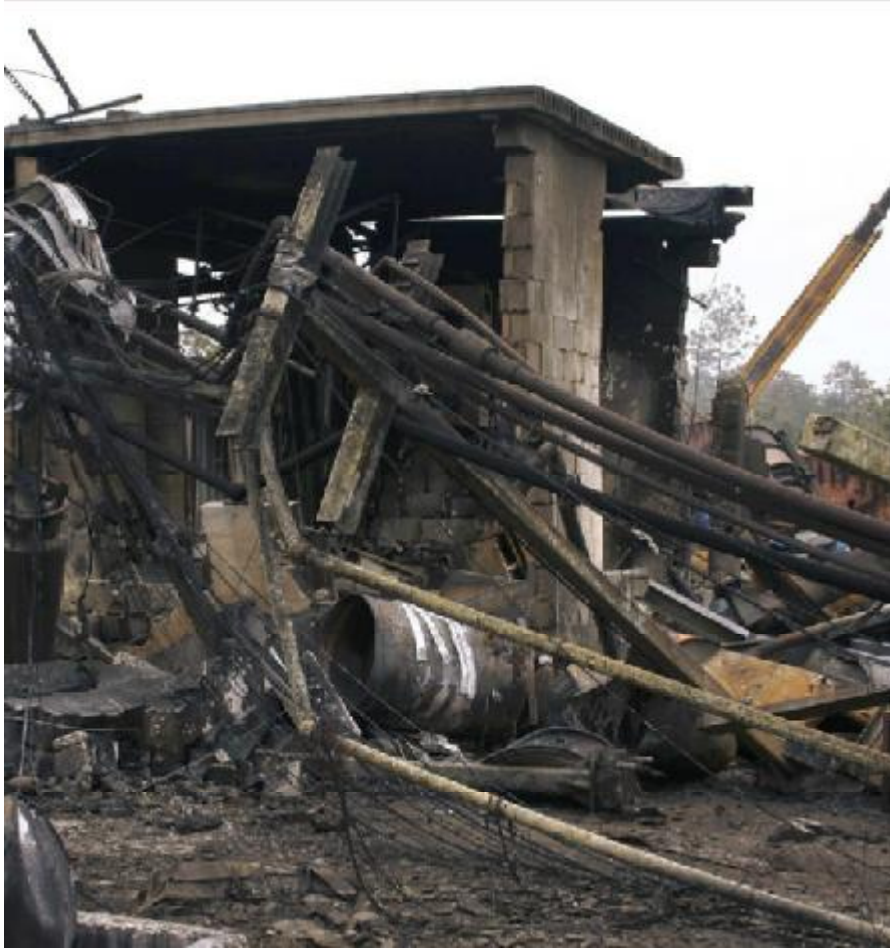
⁸ Survivors' accounts indicate that the process operator (deceased) reported a cooling system problem.

Figure 2. Control room.

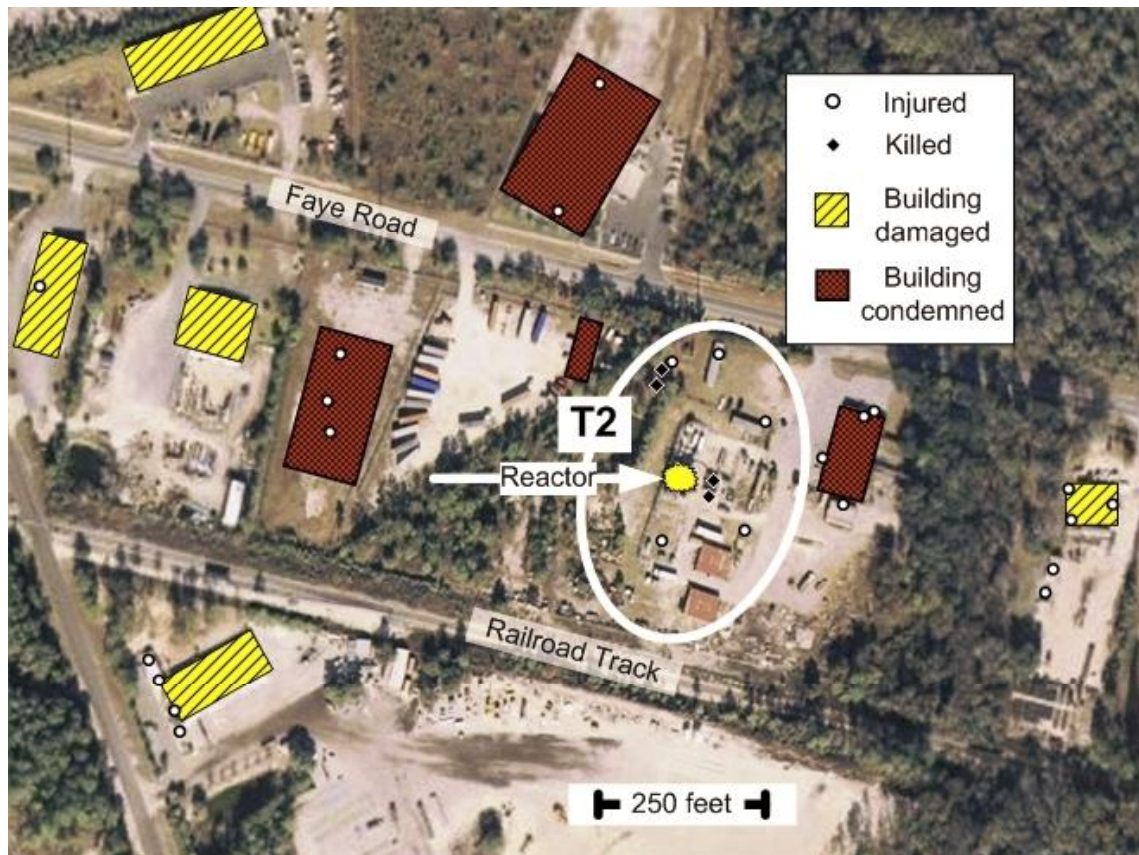
The CSB conducted a community survey of the surrounding businesses to characterize injuries and structure damage (Figure 4). At the nine businesses within 1,900 feet of the reactor, the explosion injured 27 workers. Of those, 11 suffered lacerations and contusions, seven reported hearing loss, and five fell or were thrown by the force of the blast. The CSB survey team photographed and catalogued 32 damaged structures, some as far as 1,700 feet from T2.

Figure 4. Injury and business locations.

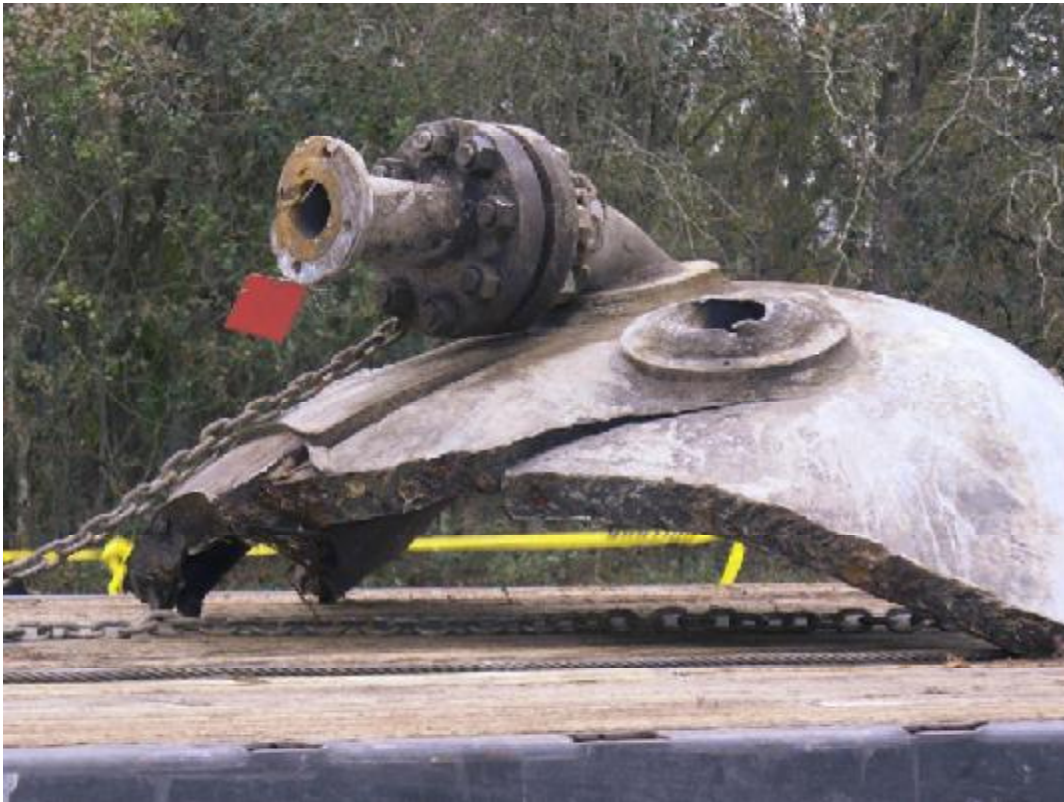
The explosion leveled the plant, propelling debris in all directions. Two large steel support columns from the reactor structure traveled about 1,000 feet along Faye Road in both directions. A 2,000-pound section of the 3-inch-thick reactor head (Figure 5) impacted railroad tracks adjacent to T2, pushing a rail out of place, before impacting and damaging a building about 400 feet from the reactor. The explosion threw piping from inside the reactor hundreds of feet onto the other businesses and wooded areas surrounding T2. The 4-inch diameter agitator shaft from the reactor was thrown about 350 feet across Faye Road in two large pieces that imbedded in a sidewalk and the ground (Figure 6).

Figure 5. Portion of the 3-inch-thick reactor.

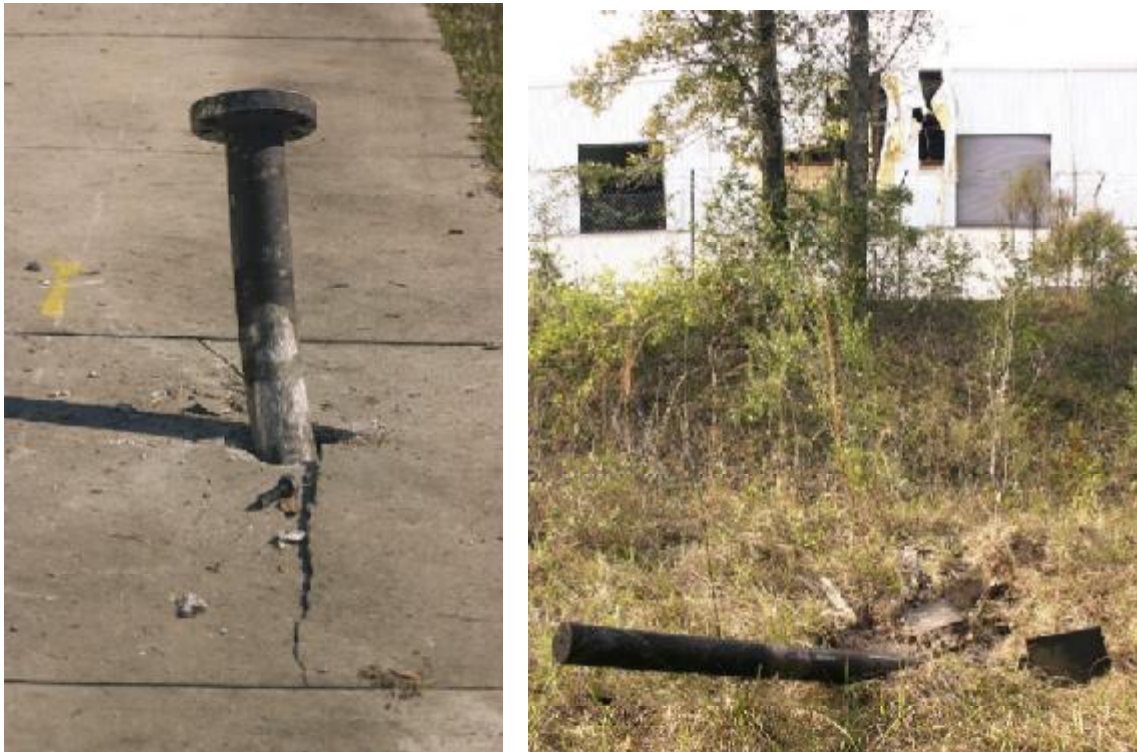
Figure 6. Agitator shaft pieces.

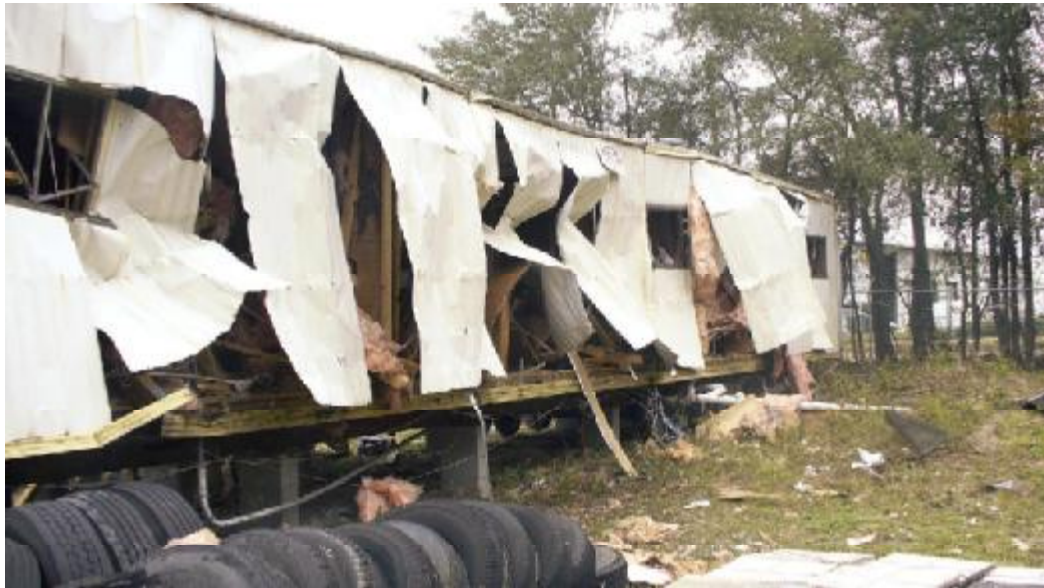
Businesses near T2 sustained heavy damage. Structures sustained window damage from the overpressure up to 1,700 feet away from T2. The explosion destroyed a trucking company office trailer located 250 feet from the reactor (Figure 7). If trucking company employees had been in the trailer at the time of the incident, it is likely that they would have been seriously injured or killed.¹¹ Two warehouses located about 400 to 500 feet from the reactor both sustained heavy damage; nine of the 25 employees at these two businesses were injured.

Figure 7. Trucking company trailer adjacent to T2.

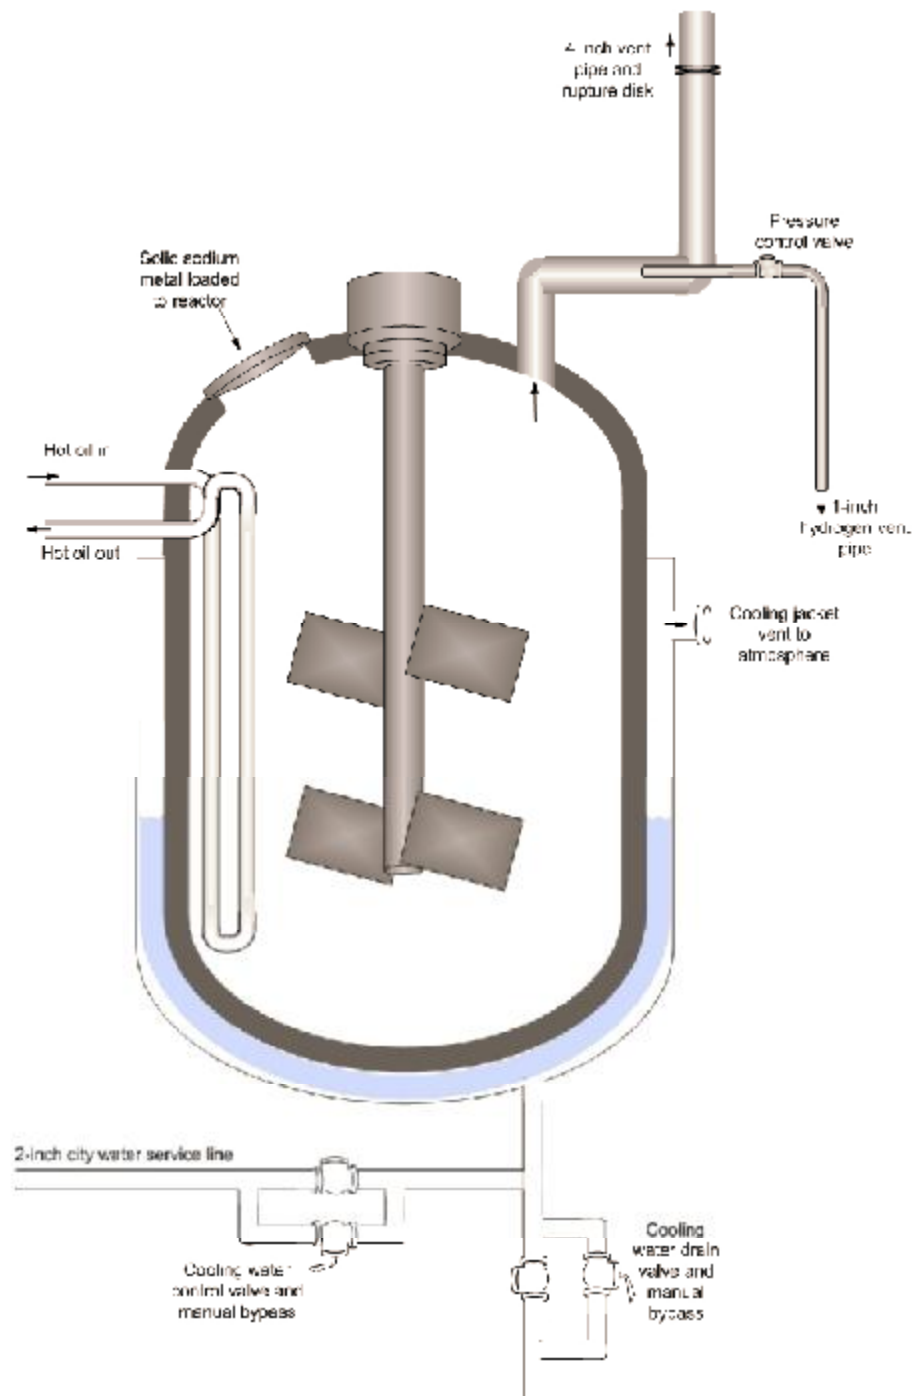
A 4-inch¹⁹ vent pipe that made two 90-degree pipe bends before connecting to a 4-inch rupture disk provided overpressure protection for the reactor. Employees stated that the rupture disk was set at 400 psig. A pressure control valve installed in a 1-inch vent pipe, which branched off of the 4-inch vent pipe below the rupture disk, controlled reactor pressure.

Figure 8. Reactor cross-section.

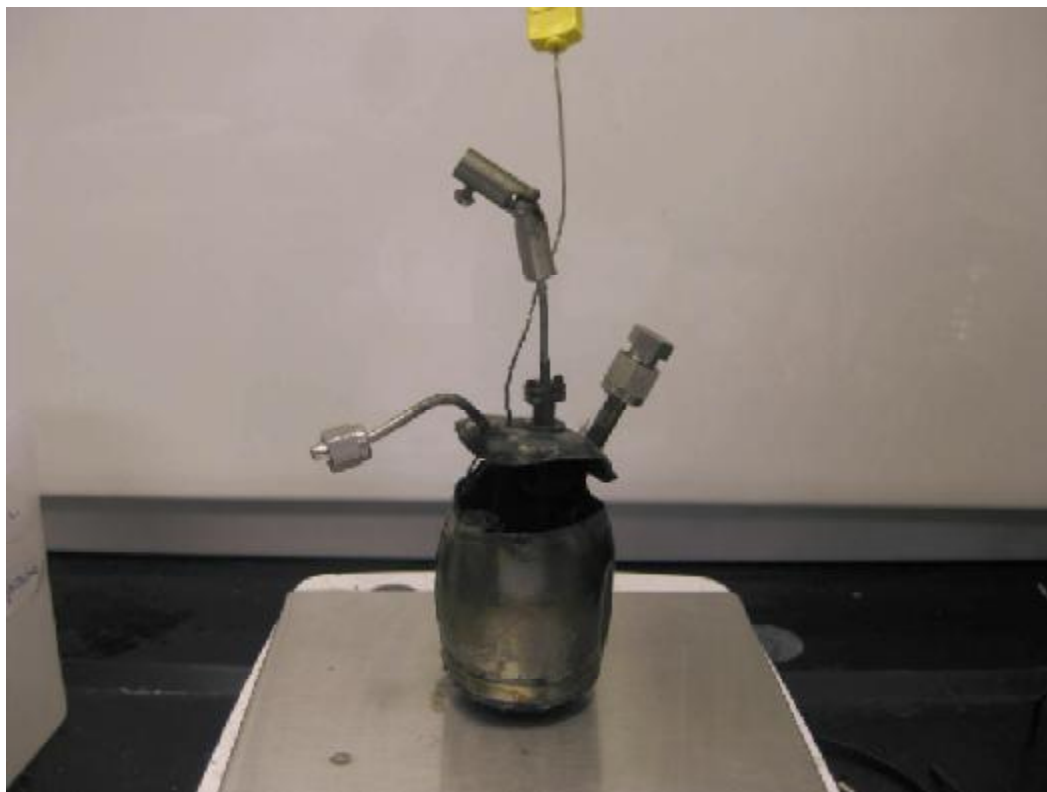
For the first two VSP2 tests, the test cell was open to the containment vessel and results similar to the ARRST tests were obtained. The CSB conducted the remaining four VSP2 tests in a closed (sealed) test cell. A second and more energetic exothermic reaction was observed when the temperature exceeded 390°F (198.9°C) in two test that used the T2 recipe. The pressure and temperature rise during the second exothermic reaction was about 32,000 psig per minute (2,206 bar per minute) and 2340°F per minute (1300°C per minute) respectively and burst the test cells (Figure 16). The other two tests performed using only sodium and diglyme solvent, suggest that this second more energetic exothermic reaction is a reaction between the sodium and diglyme solvent.

Figure 16. Burst VSP2 Test Cell.

The results of this testing show that the standard T2 chemical recipe is capable of producing the reactor failure observed on December 19, 2007. Using the data obtained from these tests, the CSB determined by calculation failure of the reactor from this second exothermic reaction could not have been prevented by an overpressure relief device. Failure could only be prevented by relieving pressure before the second exothermic reaction and allowing the MCPD and Diglyme solvent to boil and vent. Allowing the MCPD and diglyme to boil and vent removes heat from the mixture and reactants from the reactor. For T2 this would have required a rupture disk set at 75 psig in lieu of the 400 psig disk that was used.

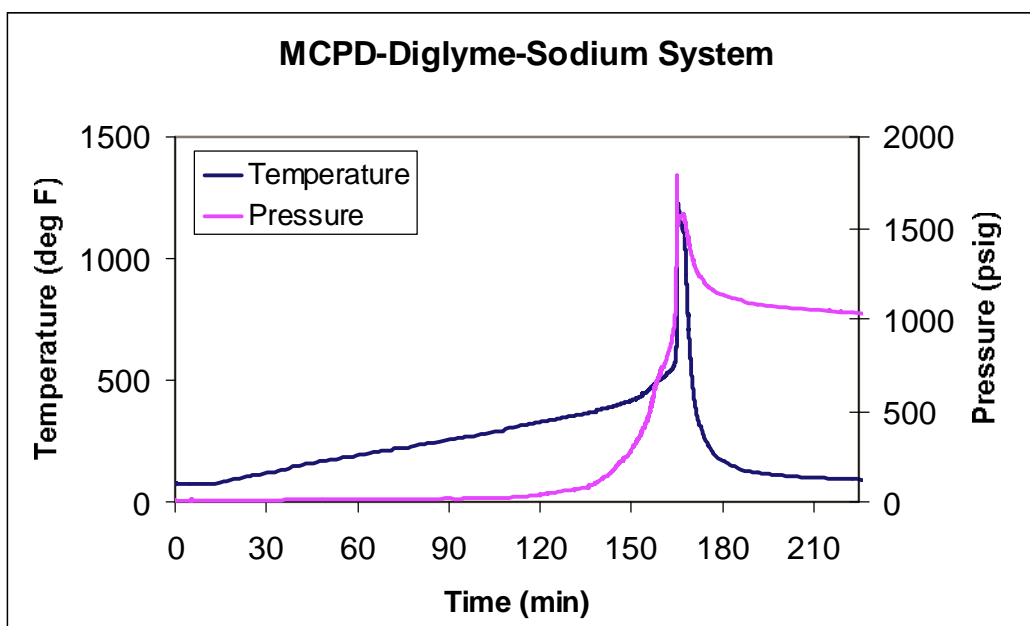
Figure 18. MCPD Diglyme Sodium Test Results.

The peak rate of temperature rise for the final test is 2340°F/minute (1300°C/minute) and the peak rate of pressure rise is 32,000 psi/minute (2206 bar/minute). In the closed system, a strong exothermic reaction occurs using the normal T2 chemical recipe.
