# CASE STUDY

## Heat exchanger rupture and ammonia release in Houston, Texas (One Killed, Six Injured)

2008-06-I-TX  
January 2011

## The Goodyear Tire and Rubber Company

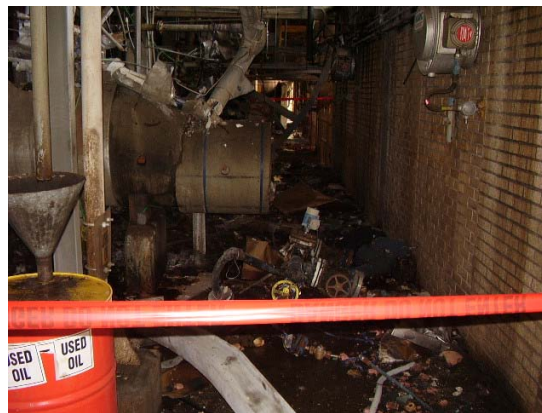
Figure 1. Area of fatality

Several hours later, after plant operations had resumed, a supervisor assessing damage in the immediate incident area discovered the body of a Goodyear employee located under debris in a dimly lit area (Figure 1).

At about 1:20 p.m., an operations supervisor assessing the damage to the incident area discovered the victim buried in rubble in a dimly lit area and contacted City of Houston medical responders.

*Companies should conduct worker headcount drills that implement their emergency response plans on a facility-wide basis. Company procedures must account for breakdowns in automated worker tracking systems to ensure that all workers inside a facility can be quickly accounted for in an emergency. Drills that simulate such malfunctions should be conducted to verify that all lines of responsibility and alternate verification techniques will account for workers in a real situation.*

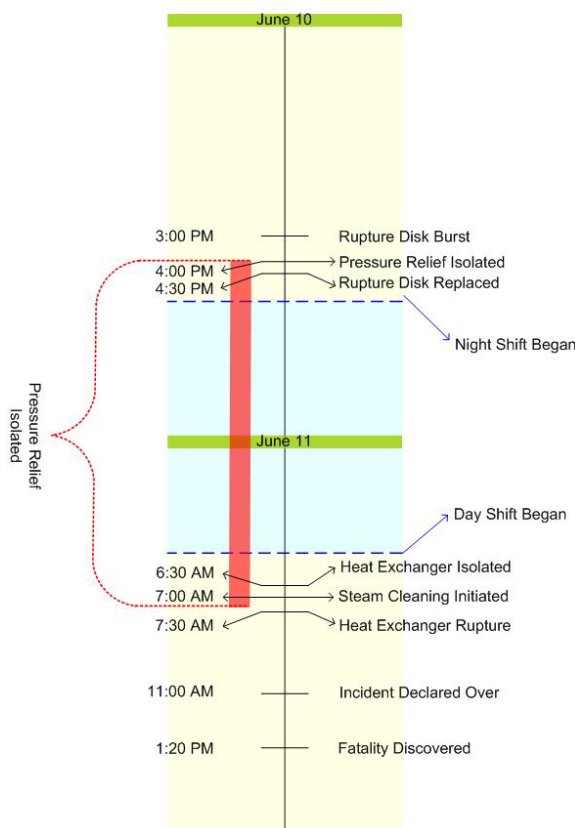
Figure 3. Event timeline

Although maintenance workers had replaced the rupture disk by about 4:30 p.m. on June 10, the valve isolating the rupture disk was not reopened. No further activities involving the rupture disk or relief line occurred on the nightshift or the dayshift on June 11 and the valve remained closed. Figure 3 shows the timeline of these events.

Goodyear's work order system for maintenance requires the process operator to sign off when the repairs are completed. However, whether this occurred during the June 10 dayshift is unclear, and Goodyear was unable to produce a signed copy of the work order.

*Communicating plant conditions between maintenance and operations personnel is critical to the safe operation of a process plant. Good practice includes formal written turnover documents that inform maintenance personnel when a process is ready for maintenance and operations personnel when maintenance is completed and the process can be safely restored to operation.*
