Tesoro Martinez Refinery

Process Safety Culture Case Study

February 12, 2014 and March 10, 2014 Sulfuric Acid Release Incidents

No. 2014-02-I-CA

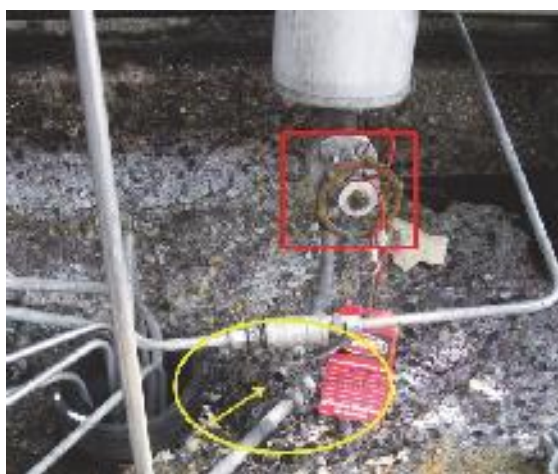
The incident occurred when the operators opened a valve (Figure 2) to return an acid sampling system back to service (Figure 3). Shortly after fully opening this valve, the tubing directly downstream of the valve came apart at the connector, spraying the two operators with acid. The operators immediately went to a nearby safety shower. Until responders were able to isolate the system, acid continued to spray out of the failed tubing for over two hours from a nearly 100,000-gallon acid settler²¹ that was operating below 100 pounds per square inch gauge (psig) and near the ambient temperature of approximately 50 degrees Fahrenheit (°F). This resulted in the release of approximately 84,000 pounds of sulfuric acid.

Figure 2. Photo showing the tubing that separated (yellow oval) after the valve (red square) was opened in order to return the sample system back to service following maintenance. Two workers were injured from this acid release incident on February 12, 2014. This loss of containment from the open-ended tubing released 84,000 pounds of sulfuric acid.

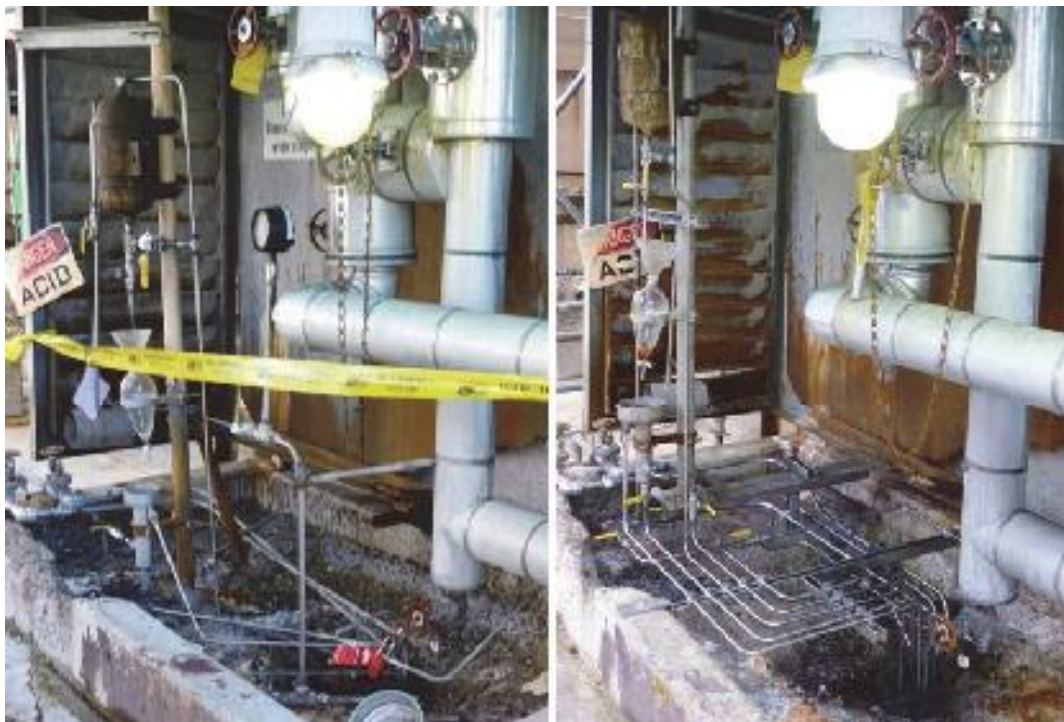
Figure 3. Photo showing the sulfuric acid sampling station at the Tesoro Martinez refinery. The photo on the left shows the sample station just after the February 12, 2014 incident and the photo on the right shows the sample station after repairs were made and the alkylation unit was again operating. Workers informed the CSB that the concrete containment area, clearly visible in the photos above, had badly deteriorated from routine exposure to sulfuric acid.

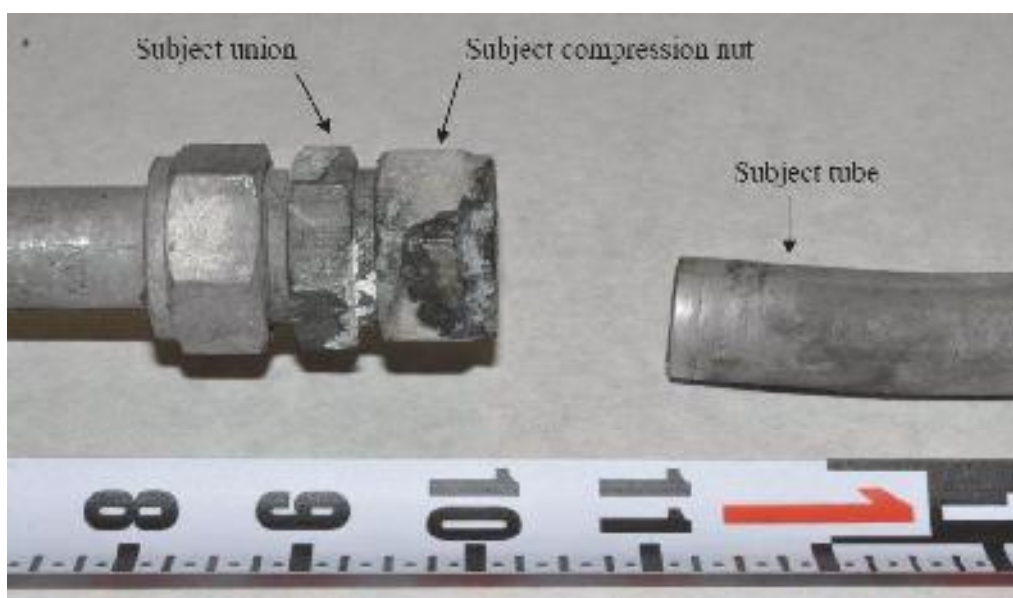
2014.²⁹ The report concluded that the sulfuric acid release on February 12, 2014 resulted from the failure of a 3/4-inch diameter stainless steel tubing connector that came apart due to insufficient tightening between a tube and a compression joint at the sulfuric acid sampling station.

Figure 4. Photo of the tubing connection that failed and resulted in the February 12, 2014 incident. This photo is from the CSB's technical evaluation report that determined the compression joint was insufficiently tightened.

Following the February 12, 2014 incident, maintenance workers also found an inadequately tightened compression fitting for an adjacent sample station. This tubing connector did not fail during start-up like the other connector, however, because the tubing was wedged against a concrete wall, holding it in place.

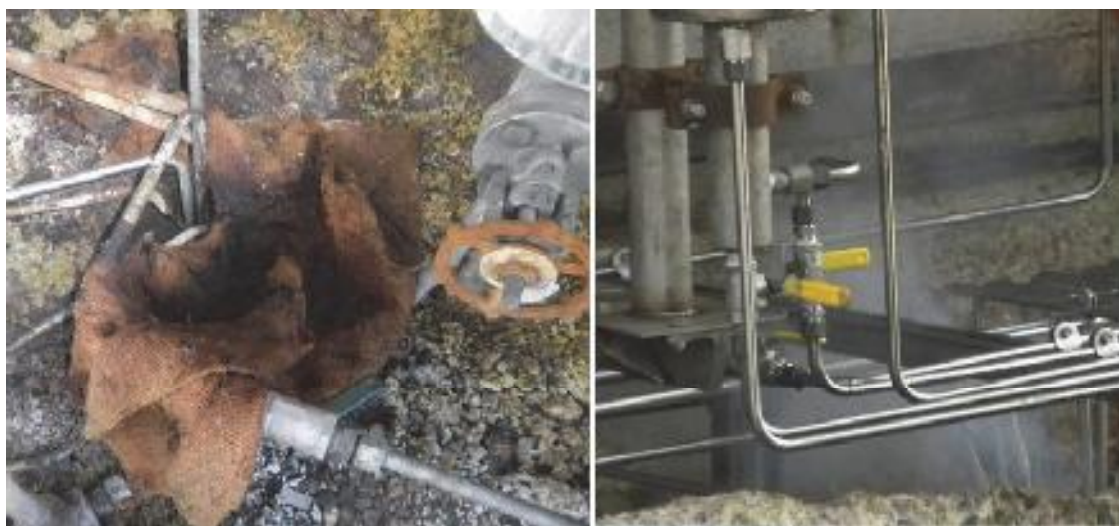
sampling. Additionally, due to the dangers this sampling station presented, the Tesoro Martinez refinery's acid sampling procedure required operators to evacuate nearby workers from the area prior to initiating the sampling procedure. Rather than reengineering the process to eliminate the vapor cloud, Tesoro placed burlap bags around the process sewer drain opening to attempt to reduce the size of the vapor cloud generated by the sampling process (Figure 5).

Figure 5. The photo on the left shows a burlap bag covering the process sewer drain at one of the Tesoro Martinez refinery sulfuric acid sample stations. The photo on the right shows the white vapor cloud released from the process sewer drain when Tesoro operators conduct the procedure to sample the sulfuric acid.

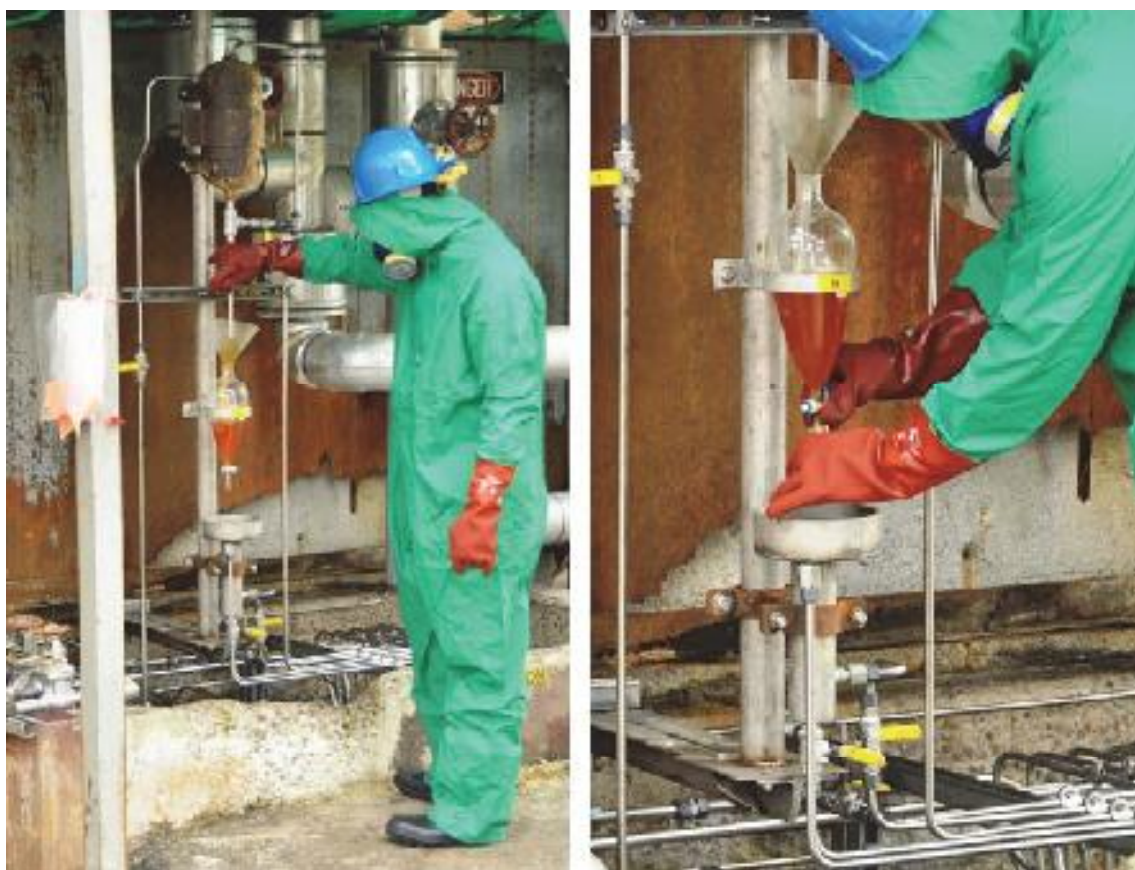
Figure 7. Photos of an operator at the Tesoro Martinez refinery taking a sulfuric acid sample. These photos were taken following the February 12, 2014 incident with the new PPE requirements in place. Tesoro's sulfuric acid sampling system requires two separate one-hour waiting periods to allow hydrocarbons to vent to the atmosphere. In addition to potential liquid acid exposure, the sampling process exposes the operator to hydrocarbon vapor, and sulfuric acid vapor. Following the incident, Tesoro upgraded the PPE requirements to include a full-face respirator and a full-body acid suit.

After the February 12, 2014 incident, Tesoro upgraded the PPE requirements during acid sampling to include a full acid suit and air-purifying respirator (Figure 7).

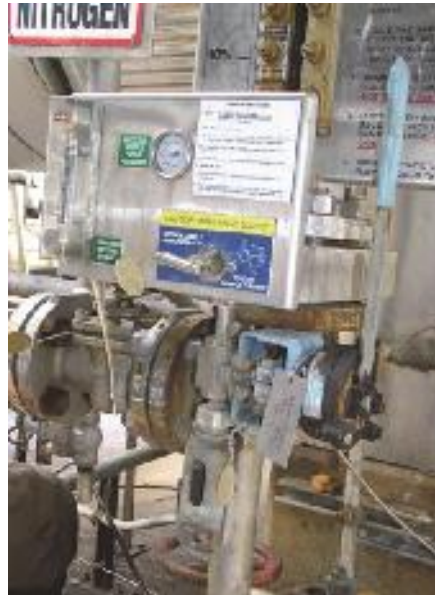
Figure 8. Photo showing one of the upgraded sample stations that Tesoro installed to reduce operator exposure to acid during sampling. Tesoro never resolved the reliability issues with these sample stations and the sample stations were taken out of service. As a result, they were not in use at the time of the February 12, 2014 incident.

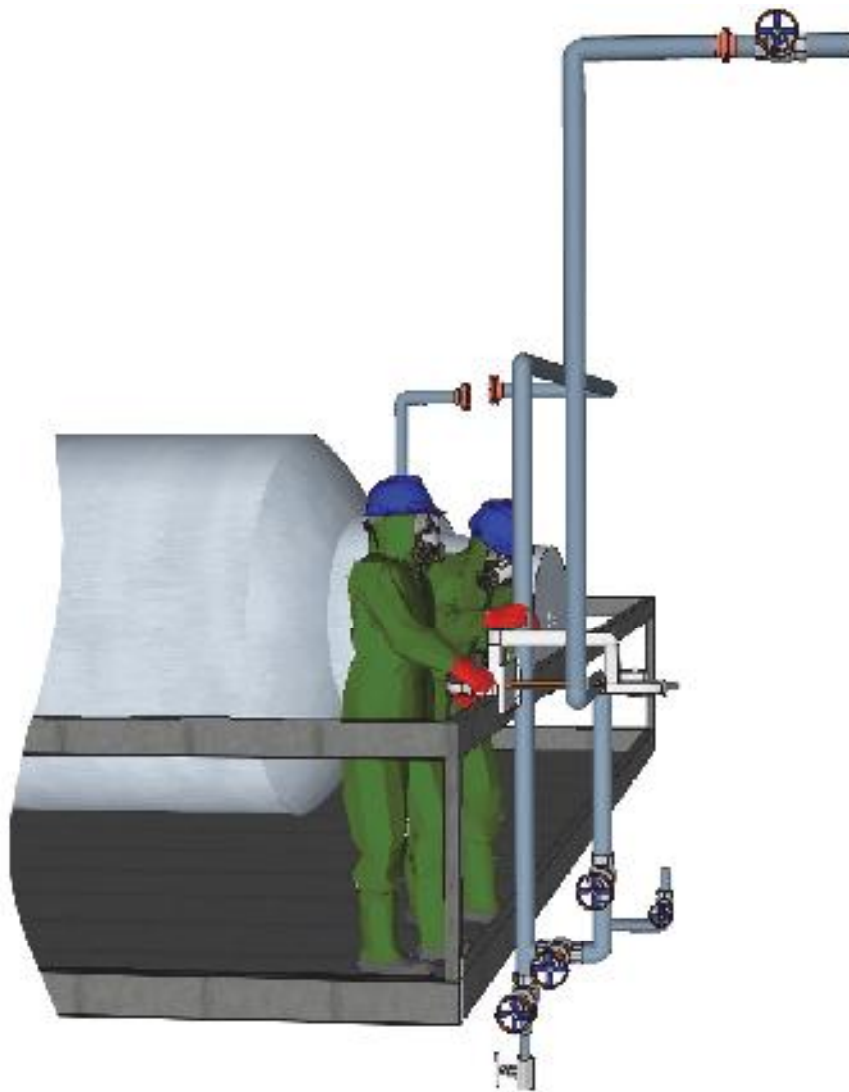
Figure 12. CSB depiction of the workers cutting the 1-inch butane piping just prior to the sulfuric acid spray incident on March 10, 2014.

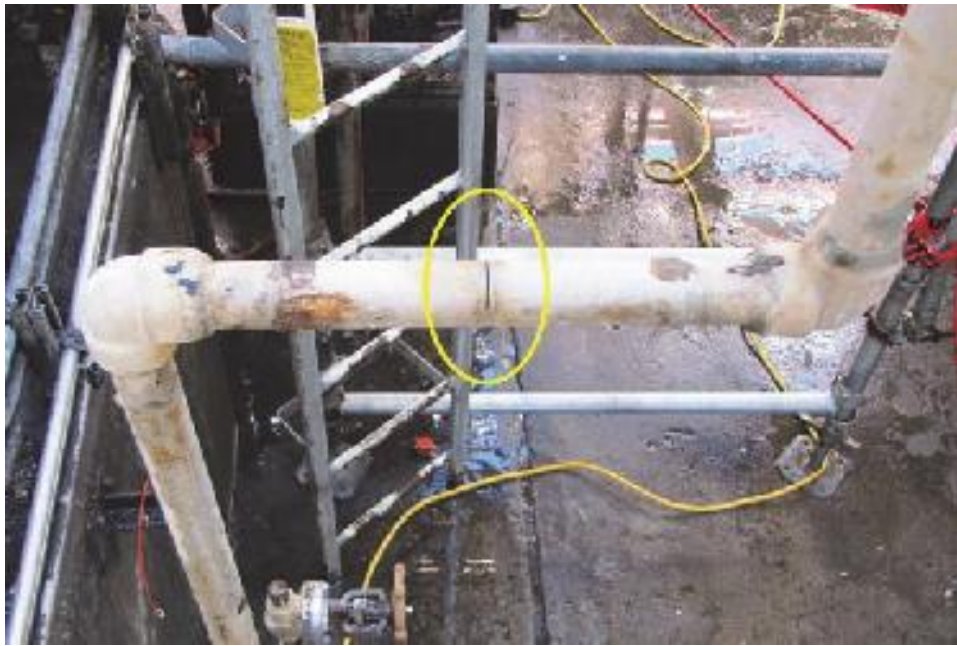
Figure 13. Photo of piping involved with the March 10, 2014 incident. The yellow oval shows the cut the workers made using a band saw that resulted in the acid release. Figure 14 also shows the location of this piping.

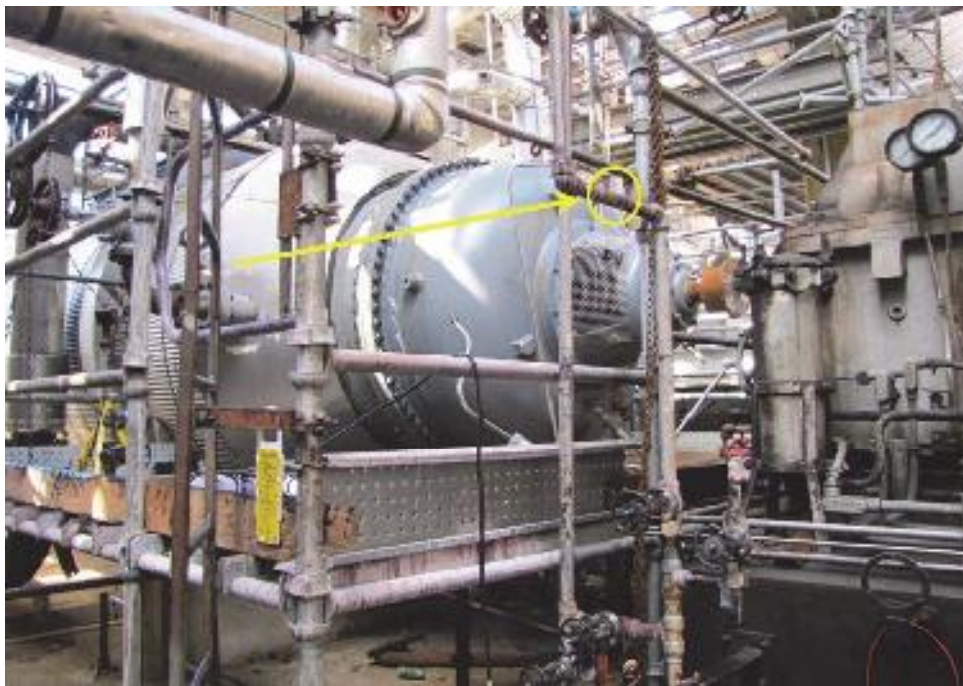
Figure 14. Photo of location of the March 10, 2014 incident. As depicted in Figure 12, two workers were located on this temporary scaffold platform and were cutting the piping (yellow circle) with a portable band saw.

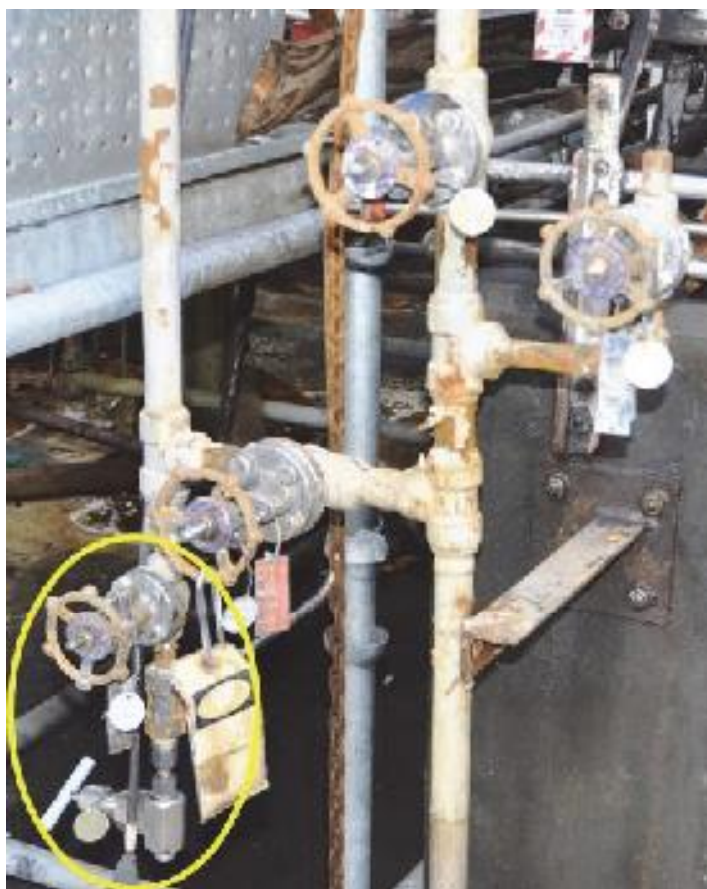
A Tesoro alkylation unit operator stated to the CSB that on the day of the incident he understood (correctly) that the “line had already been opened once before.” In addition, the system was blinded on one end and locked closed on the other, giving him no reason to believe the pipe was not already empty and safe for workers to cut and remove. Regardless, prior to issuing the hot work permit for the job, the operator opened a drain valve associated with the piping system and he observed what appeared to be a “wisp” of butane vapor come out of the valve. The operator then used his gas meter to perform an atmospheric check for additional hydrocarbon flow from the drain valve, and found none. The operator explained: “So to me that meant that the line, in my mind, was cleared because I didn’t have a pressure gauge on that line to determine if there was in fact any pressure on there.” The contract workers who were present to cut and remove the piping also both knew the pipe was worked on before, had already been disconnected from the alkylation reactor with a blind flange installed, and saw that the drain valve was opened with no hydrocarbons detected on the operator’s gas meter. These factors reinforced to them the appearance of a safe condition for performing the work. After the incident, however, it was determined that the drain piping was internally plugged, preventing flow through the open drain valves, and as a result it provided the operator and contract workers with a false sense of security that the piping had been depressurized and drained of its contents (Figure 16).

Figure 16. Photo of drain piping and valves. Evaluation of this equipment after the incident identified plugging in these piping components that prevented liquid from freely draining through the open valves.

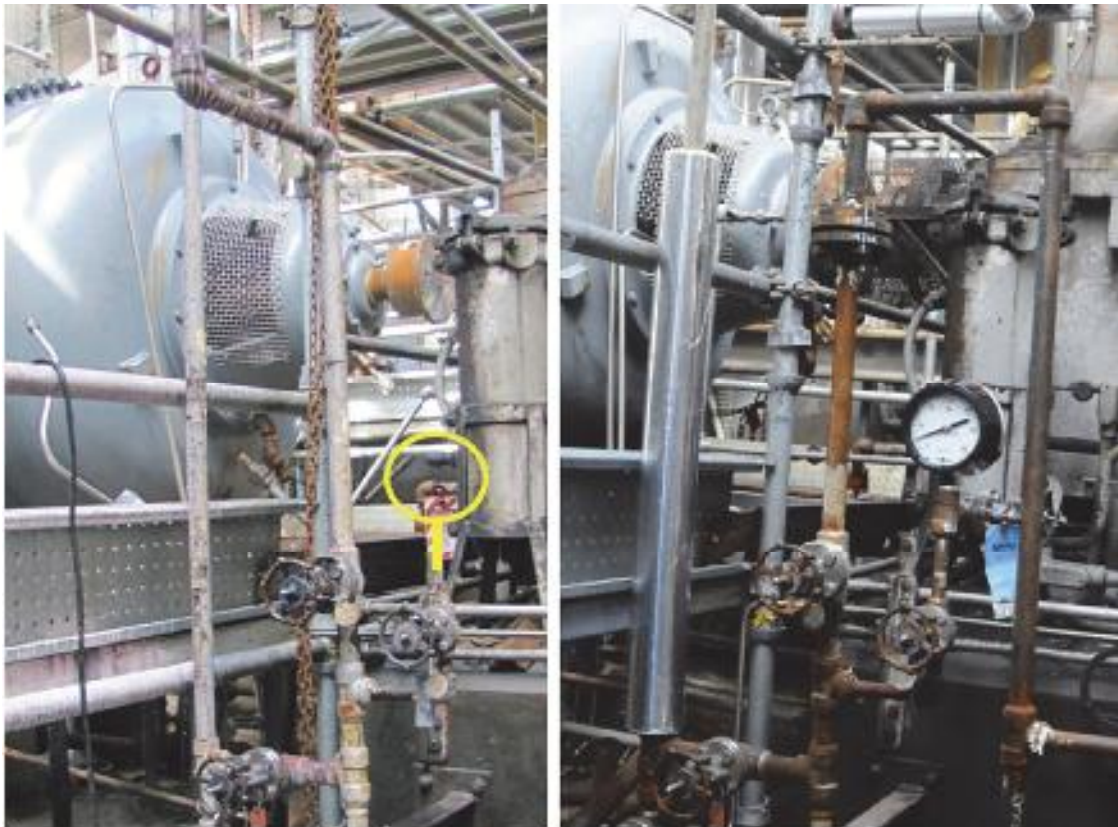
As a result, the operator and contractors did not take any extra steps to ascertain whether the piping was properly drained and depressurized. All available evidence suggested that the pipe was properly drained and depressurized. Combined with the fact that the pressure indicator on this piping system was not available to alert the workers to hazardous conditions (because the pressure indicator had been previously removed and replaced with a plug as shown in Figure 17), the operator had no indication of the dangerous condition – that a pressurized inventory of concentrated (94 weight percent) sulfuric acid remained in the piping.⁴²

Figure 17. Photo of piping involved with the March 10, 2014 incident (left photo). The photo on the right shows the piping after repairs were made and the pressure indicator was reinstalled. Note the yellow circle in the photo on the left that shows the location where a pressure indicator was supposed to be located, but had been removed. Had this pressure indicator been available it could have alerted workers that dangerous pressure remained in the piping system.

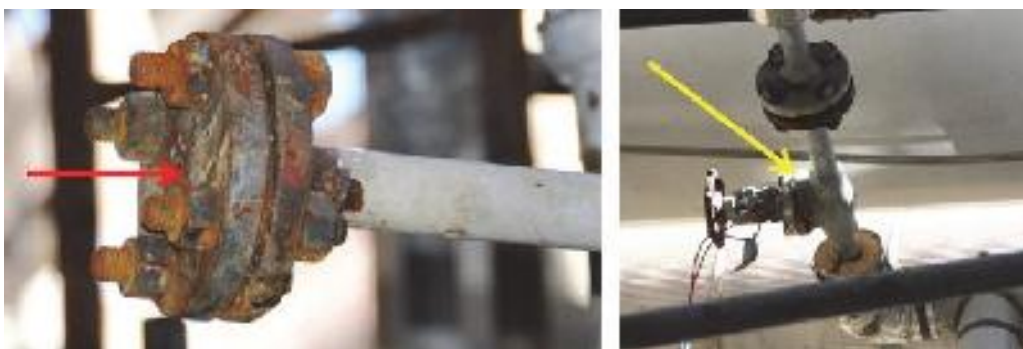
In December 2013, workers disconnected the butane piping involved in the incident from the alkylation reactor, and then installed a blind flange on the reactor side in accordance with Tesoro standards and good industry practice, as shown in Figure 18. On the butane supply side, however, Tesoro relied on a single isolation valve, rather than disconnecting and/or blinding, contrary to corporate standards. The CSB learned that this was a common practice at the Tesoro Martinez refinery’s alkylation unit during hot work that involved “low energy” tools that met the site’s concept of “low risk.” The Tesoro Martinez policy defines “high risk” work as jobs that involve working on high-pressure systems, high hydrogen sulfide, sulfur dioxide, ammonia, and process streams above the auto ignition temperature. The policy provided no actual definition of “low risk.” The workers commonly understood that “low risk” applied to anything not defined as “high risk.” The workers considered the task performed on March 10, 2014, to be “low risk” work with a “low energy” cutting tool.

Figure 18. Photo of piping isolation at time of March 10, 2014 incident. The photo on the left shows the piping isolation on the reactor side. A blind flange (red arrow) was installed in December 2013 when the piping was disconnected from the alkylation reactor. The photo on the right (yellow arrow) shows the single valve used to isolate butane from the piping workers were cutting.

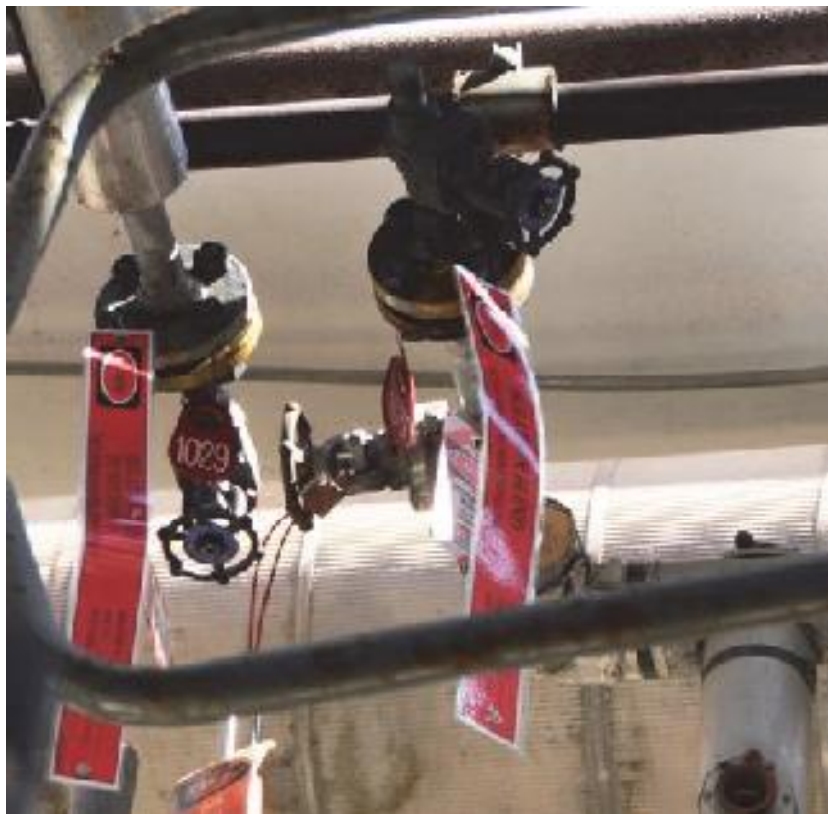
Figure 19. Photo of post-incident isolation of liquid butane supply piping to alkylation reactor. This photo shows the same piping shown in the right photo of Figure 18. Two days after the March incident, Tesoro modified the liquid butane isolation to match the API recommend practice, Tesoro’s corporate standards requirement, and Tesoro Martinez procedure recommendations by disconnecting and installing isolation flanges on each end of the isolated piping.

Two days after the March 2014 incident, Tesoro modified the isolation for the liquid butane piping from using single valve isolation to blinding, a more robust isolation approach that followed the best practice methods detailed in refinery procedures, corporate standards, and industry standards (Figure 19). Had Tesoro followed its own standards and recommended practices during the initial December 2013 isolation of this butane piping system, the March 10, 2014 incident could have been prevented. Piping should have been flushed to remove the acid, drained to ensure no residual liquid, and blinded to eliminate the potential for a slow leaking valve to pressure the piping system.
