# Safety Bulletin

## Key Lessons for Preventing Incidents When Preparing Process Equipment for Maintenance

### Flash Fire at the Delaware City Refinery

No. 2015-01-I-DE

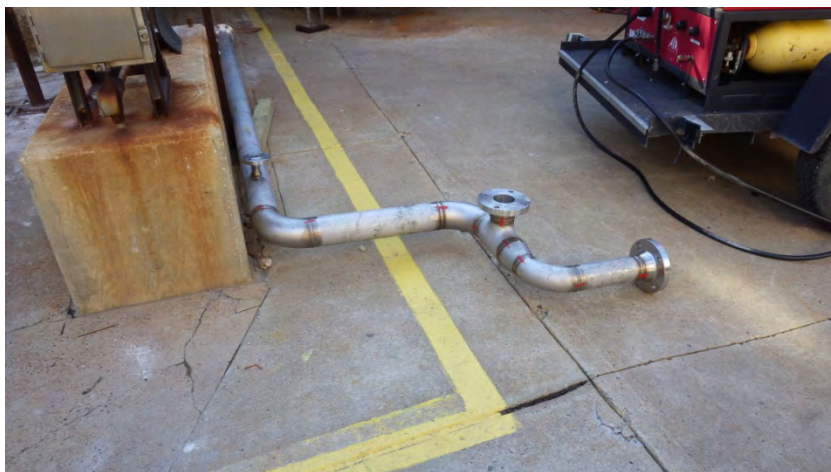
**FIGURE 2.** 20-foot replacement piping (Source: CSB).

On the day of the incident, alkylation unit operators were preparing equipment for turnover to the maintenance department, scheduled for the following day. The unit remained under the operations staff control throughout the equipment preparation activity, up to and including when the incident occurred. The maintenance activity involved replacing a 20-foot section of thinning piping located between the caustic settler drain line and the caustic recirculation pump (Figure 1) that was identified during a routine inspection process a month prior (Figure 2).

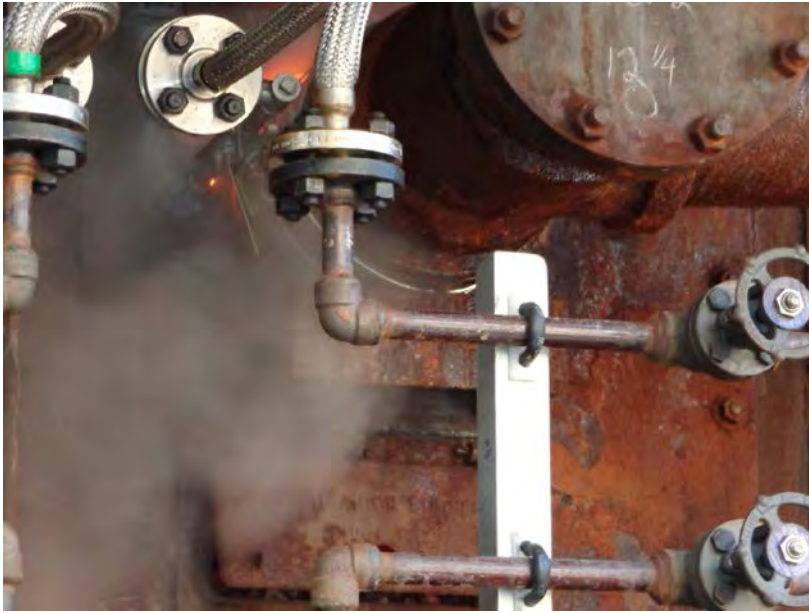
**FIGURE 7.** Burner on furnace (Source: CSB).

<sup>10</sup> The investigation team concluded that the furnace, operating on an adjacent process unit downwind of the maintenance preparation activity, was the most likely source of ignition. The injured operator recalled the fire advancing toward him from the direction of the furnace. Isobutane vapors are known to travel to the source of ignition and flash back. The atmospheric conditions on the day of the incident would have allowed for the isobutane vapors to travel in the direction of the furnace.

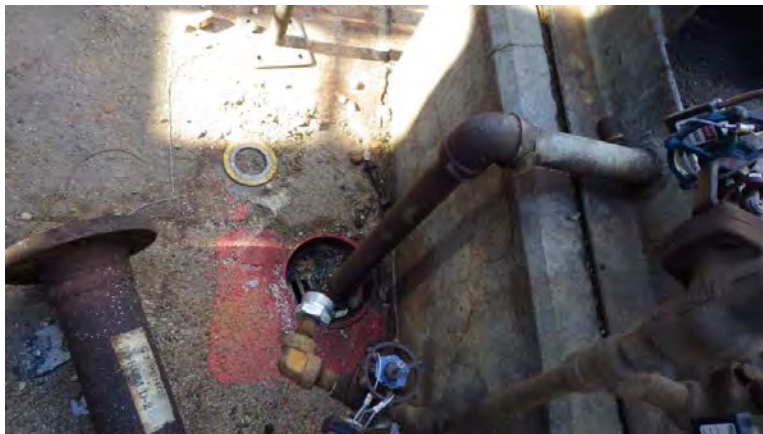
**FIGURE 8.** Typical pump drain to OWS (Source: CSB).
