U.S. CHEMICAL SAFETY AND HAZARD INVESTIGATION BOARD

INVESTIGATION REPORT

T2 LABORATORIES, INC. RUNAWAY REACTION (Four Killed, 32 Injured)

REPORT NO. 2008-3-I-FL

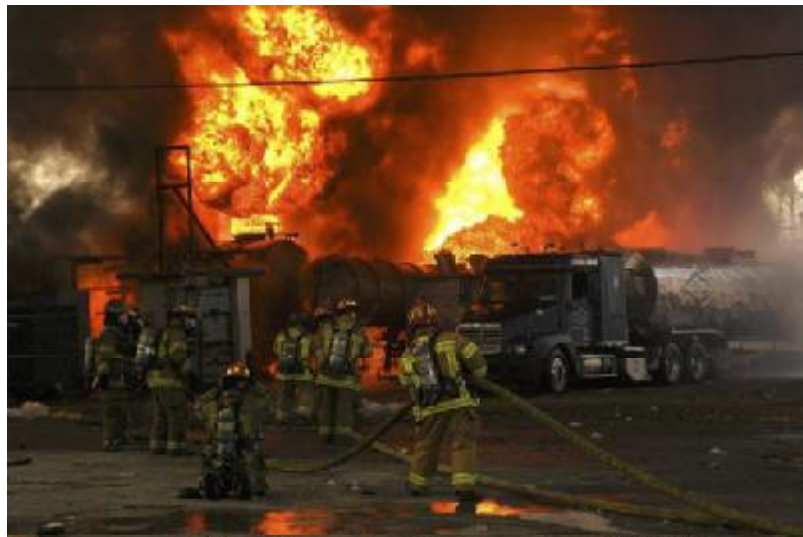
Figure 3. JFRD responders in SCBA battle fire.

At 1:33 pm, Jacksonville 911 dispatchers began receiving calls about the incident. The Jacksonville Fire and Rescue Department (JFRD) and Jacksonville Sheriff's Office (JSO) responded and set up unified Incident Command. Within 10 minutes of the incident, two JFRD hazardous materials stations dispatched.

JFRD completed a hazard analysis using material safety data sheets (MSDSs) from the T2 website.⁹ The incident commander (IC) ordered a half-mile evacuation radius, closing Faye Road and an adjacent railroad track. The IC ordered full personal protective equipment, including bunker gear¹⁰ and self-contained breathing apparatus (SCBA) for all personnel entering the area. About 90 firefighters from JFRD, the U.S. Naval Air Station Mayport Fire Department, and the Jacksonville International Airport Fire Department responded to the incident, battling the fire for many hours as stored solvents burned (Figure 3). Despite the large amounts of toxic MCMT and water-reactive sodium metal stored onsite, no responders were injured.

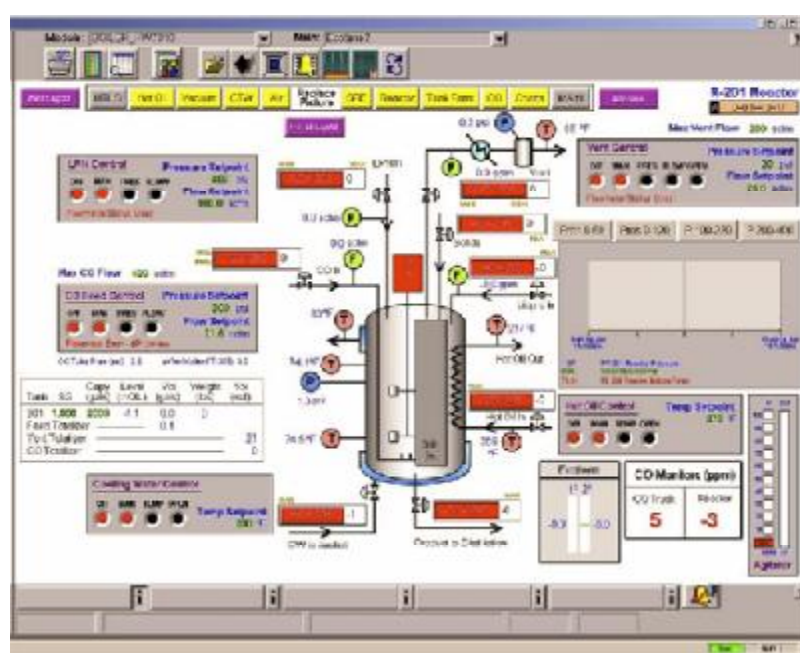
Figure 9. Process control system screen.

Each MCMT production step required the process operator to add raw materials and adjust heating, cooling, and pressure using a computerized process control system (Figure 9). On December 19, 2007, the incident occurred during the first (metalation) step of the reaction. The second and third steps of the reaction, which did not occur on December 19, 2007, were also conducted within the reactor. Appendix A discusses the complete reaction chemistry.

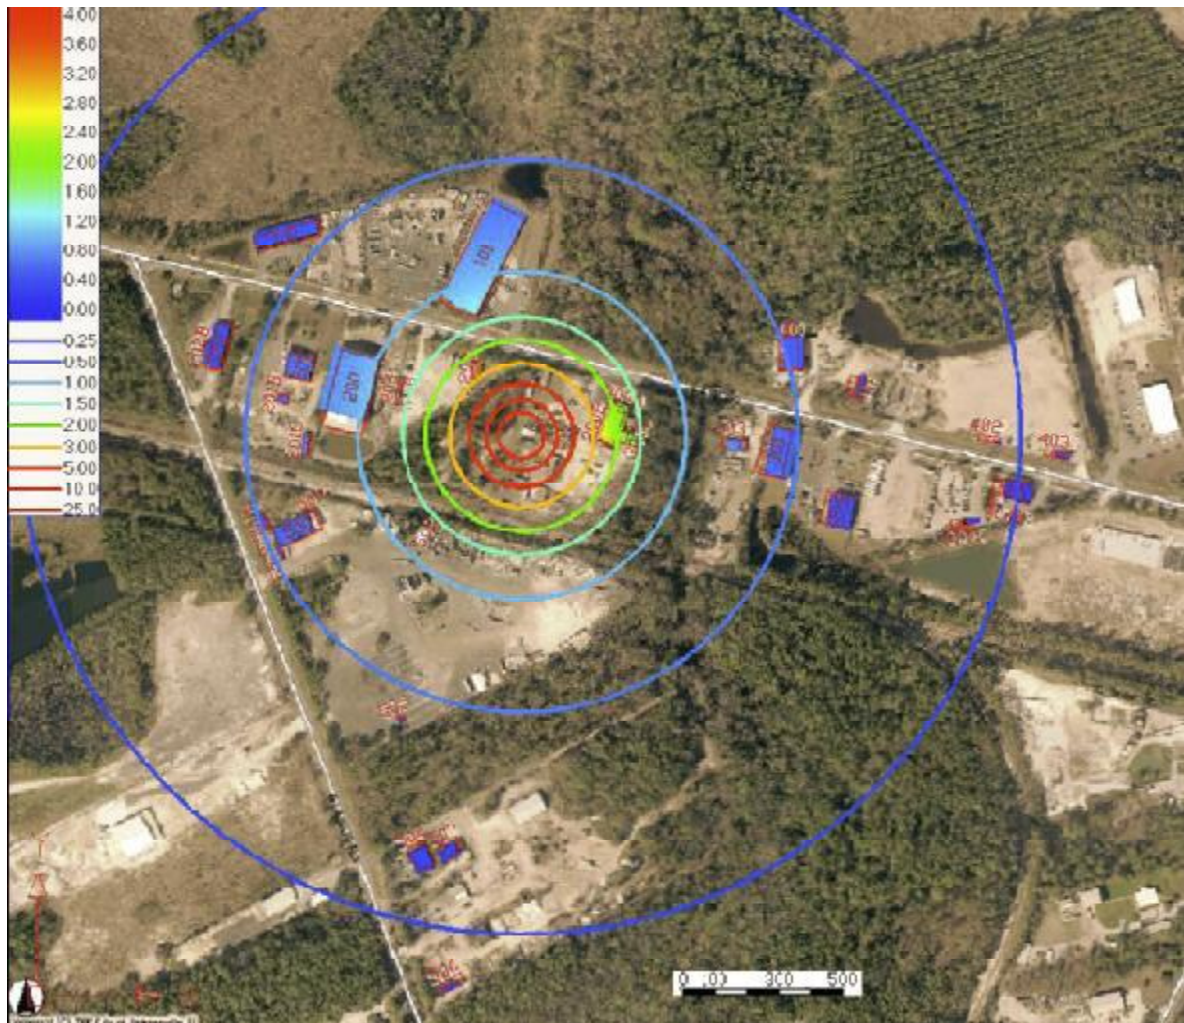
Figure 13. Free-Field Pressure Contours for Estimated TNT Yield of Explosion.

Table 1. Distance to Pressure Contours from Explosion Center for 1,420 lb TNT Yield.

Free-Field Pressure (psi)	Distance from the Source (ft)	Corresponding Free-Field Impulse (psi-ms)
0.25	1,559	7.14
0.5	863	13
1	511	21.9
1.5	372	29.8
2	299	36.8
3	225	48.4
5	162	65.8
10	110	92.6
25	70.6	136.6

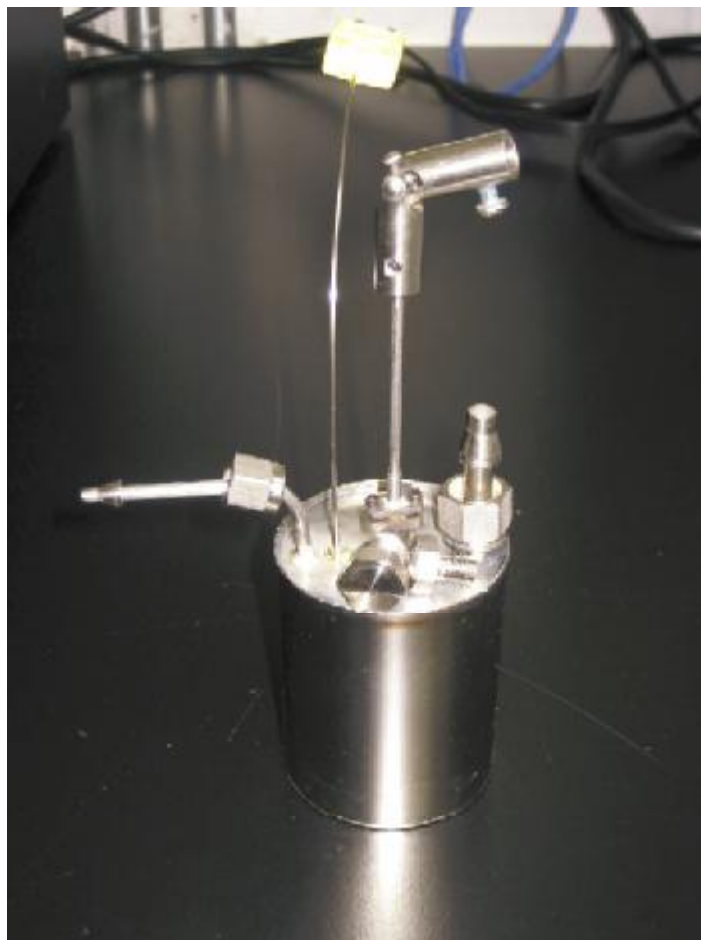
Figure 15. New VSP2 Test Cell.

Therefore, to more closely match the conditions at T2, the CSB ran a second series of six tests using the larger VSP2 test cell (Figure 15).

The VSP2 mimics the T2 facility's physical arrangement more closely and can accommodate more intense stirring to improve mixing of the chemical components. The VSP2 also incorporates baffles in the test cell which provide turbulence and shear in the liquid. These features reduced the molten sodium droplet size and increased contact between the molten sodium and the MCPD, similar to the mixer in the T2 reactor.
