Tesoro Martinez Refinery

Process Safety Culture Case Study

February 12, 2014 and March 10, 2014 Sulfuric Acid Release Incidents

No. 2014-02-I-CA

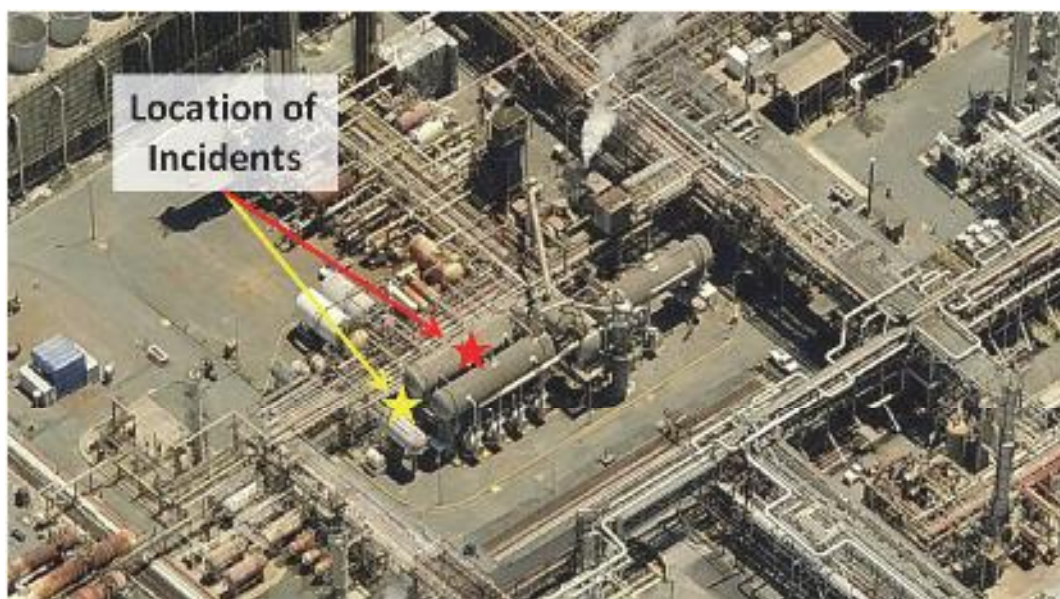
Figure 1. Overhead photo of the Tesoro Martinez refinery Alkylation Unit showing the approximate location of the February 12, 2014 (yellow star) and March 10, 2014 (red star) incidents. Credit Bing Maps.

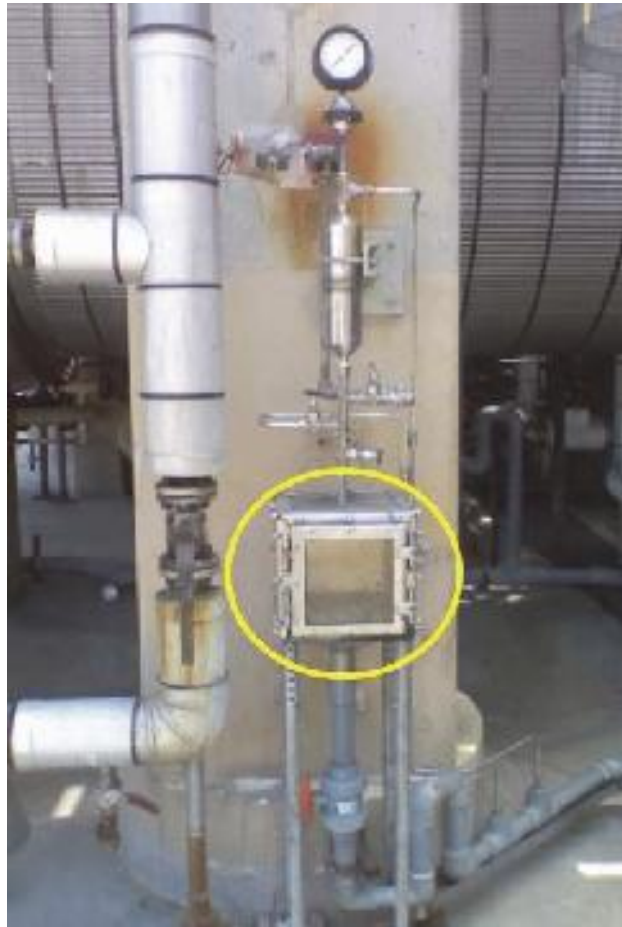
Tesoro records indicate that the Martinez refinery's sulfuric acid alkylation unit acid sampling system has more potential for operator exposure to acid than those in use at the other Tesoro refinery in California, Tesoro's Los Angeles refinery, which uses an enclosure around the sampling system to protect operators from potential acid spray (Figure 9).

Figure 9. Photo of the sulfuric acid sample station at the Tesoro Los Angeles refinery. This sample system includes an enclosure at the sample point to protect operators from potential acid spray.

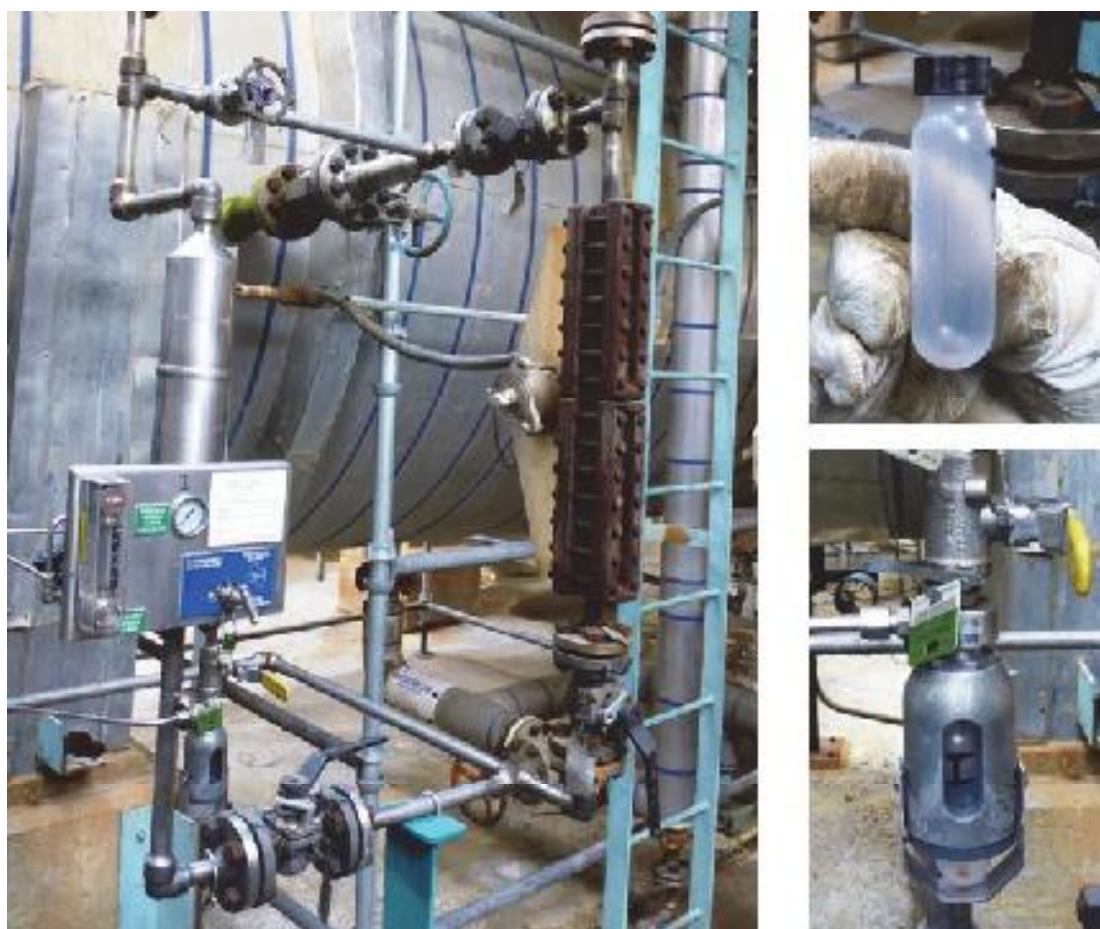
Company X refinery's sulfuric acid alkylation unit acid sampling equipment (Figure 10) is similar to the inherently safer system that Tesoro installed but took out of service. Company X initiated efforts to upgrade its alkylation unit sample stations in 2012. The design justification for the upgrade includes improved design that would be safer because it would minimize the potential for worker exposure to sulfuric acid. Company X also uses a more robust piping material due to the "extremely high" corrosivity of the sulfuric acid. Company X installed these sample systems in 2013 and the CSB learned that although these systems had some initial reliability problems similar to those Tesoro Martinez experienced, Company X successfully transitioned to its more robust sample systems.

Figure 10. Photo of the sulfuric acid sample station at the Company X refinery. The photo on the left shows a typical sample station used by Company X workers to obtain sulfuric acid samples. The photo on the top right shows a typical sample bottle and the photo on the bottom right shows the sample bottle installed to obtain a sample.

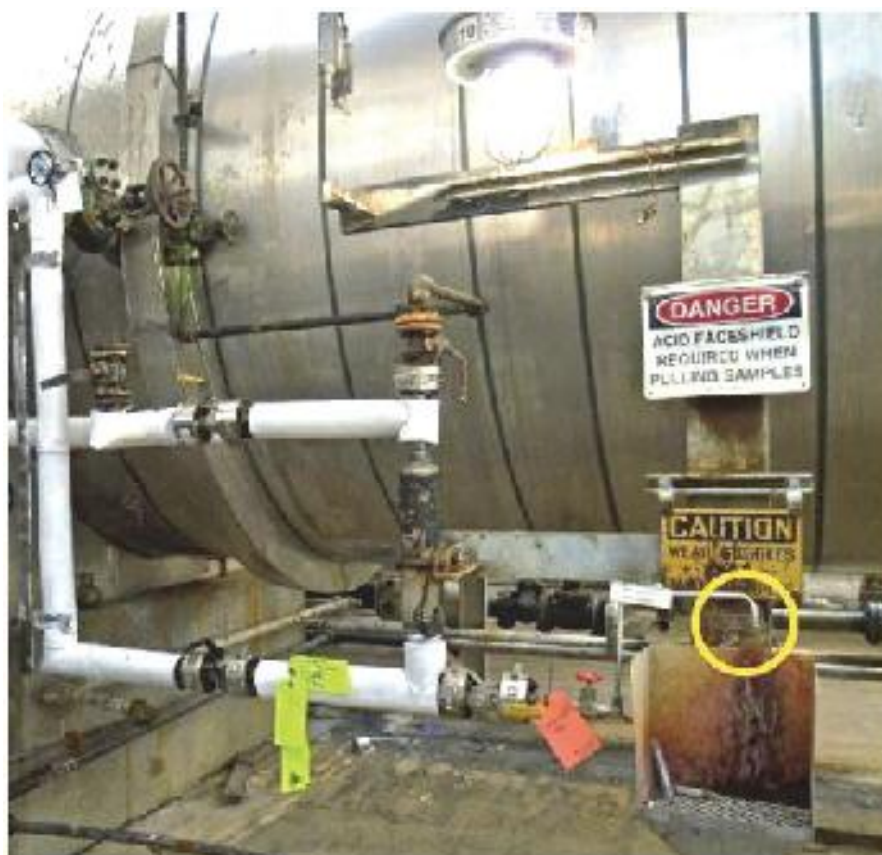
Acid sampling equipment within the sulfuric acid alkylation unit at the Company Y refinery is also more robust than the system at Tesoro Martinez involved in the February 12, 2014 incident.³⁶ Company Y's acid sampling equipment consists primarily of piping with only a short section of tubing used to collect the acid sample (Figure 11). The sampling equipment (piping, valves, and tubing) used by Company Y is better designed and maintained than the equipment at the Tesoro Martinez refinery (left photo in Figure 3).

Figure 11. Photo of the sulfuric acid sample station at the Company Y refinery. The photo shows a typical sulfuric acid sampling station at the refinery. The yellow circle identifies the location where the operator obtains the acid sample.
