U.S. Chemical Safety and
Hazard Investigation Board

Chemical Reaction, Hydrogen Release, Explosion, and Fire at AB Specialty Silicones

Waukegan, IL | Incident Date: May 3, 2019 | No. 2019-03-I-IL

Investigation Report

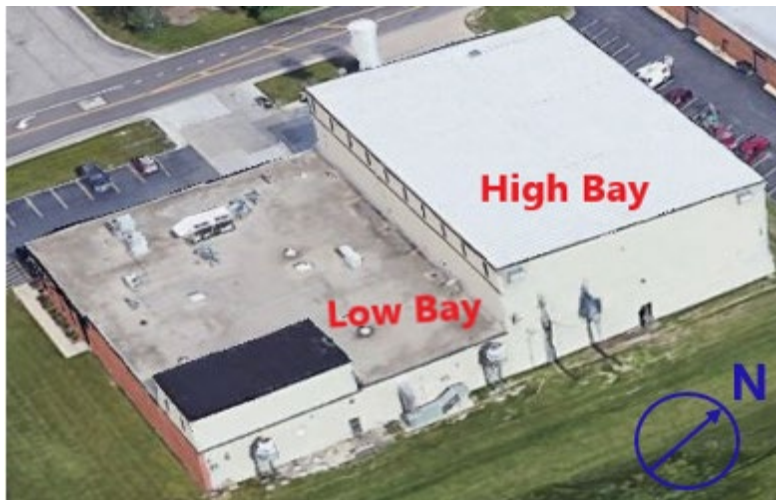
The AB Specialty operation took place inside a production building. The production building was divided into two adjoining areas known as the “High Bay” and the “Low Bay,” named after the physical heights of the structures (**Figure 2**). These bays were subdivided into different production areas, including the “emulsions area,” in which the incident occurred (**Figure 3**), and were equipped with reactors, tanks, storage vessels, and other equipment for the manufacture of various silicone products.

Figure 2. AB Specialty production building. (Credit: Google Maps with annotations by CSB)

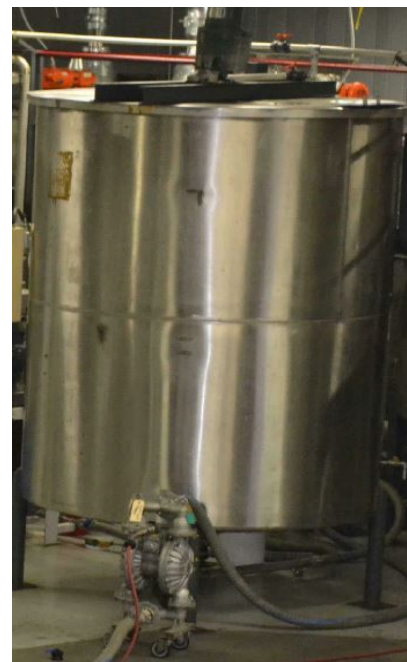
The first steps of the batch manufacture of EM 652 specified on the batch ticket included mixing multiple drums of a polymer branded as Andisil® XL 10 (XL 10)^b with a surfactant called TD 6/12 Blend in a tank (**Figure 4**).^c These steps were followed by subsequent chemical additions and mixing using additional process equipment and operations as described in **Appendix A**. The batch ticket in use at the time of the incident was not found after the incident.

Figure 4. Exemplar AB Specialty batch tank with agitator and lid. (Credit: AB Specialty)

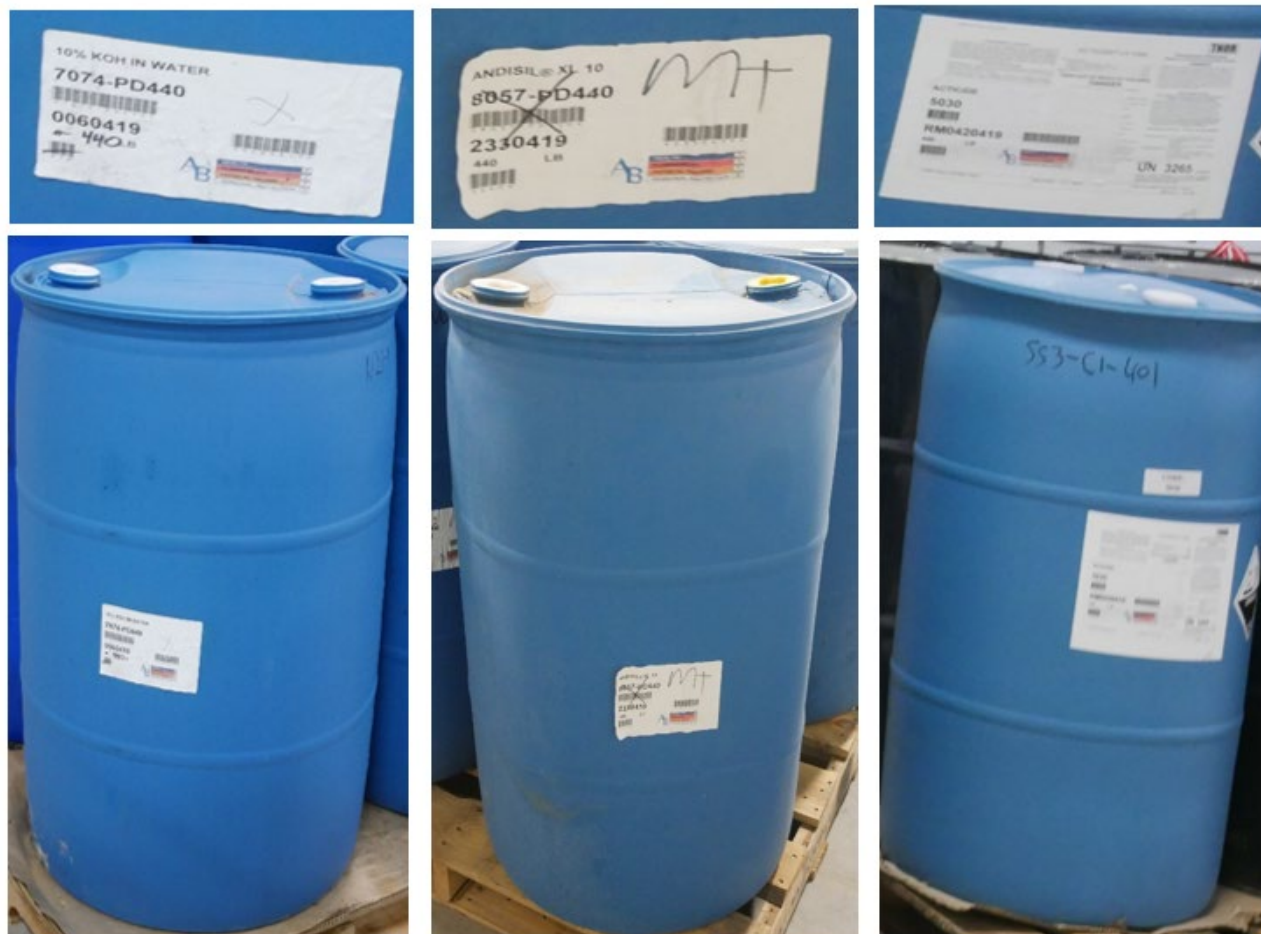
AB Specialty did not have a written procedure requiring employees to segregate the 10% KOH and XL 10 drums in the emulsions area or to remove ingredient containers from the emulsions area after use. Some chemical ingredients used in the production of EM 652, including 10% KOH and XL 10, were stored in similar 55-gallon blue plastic drums (**Figure 5**). The drums were equipped with two bung caps, often either yellow or white; the XL 10 drums typically had one white and one yellow bung cap,^a and the 10% KOH drums usually had two white bung caps. Once these bung caps were removed, the drums looked nearly identical. Therefore, AB Specialty relied on its operators to confirm drum content based on the label affixed to the side of the drum, which used small text for the chemical name, as shown in **Figure 5**.

Figure 5. Three similar AB Specialty storage drums. From left to right: 10% KOH, XL 10, and Acticide.
(Credit: CSB)

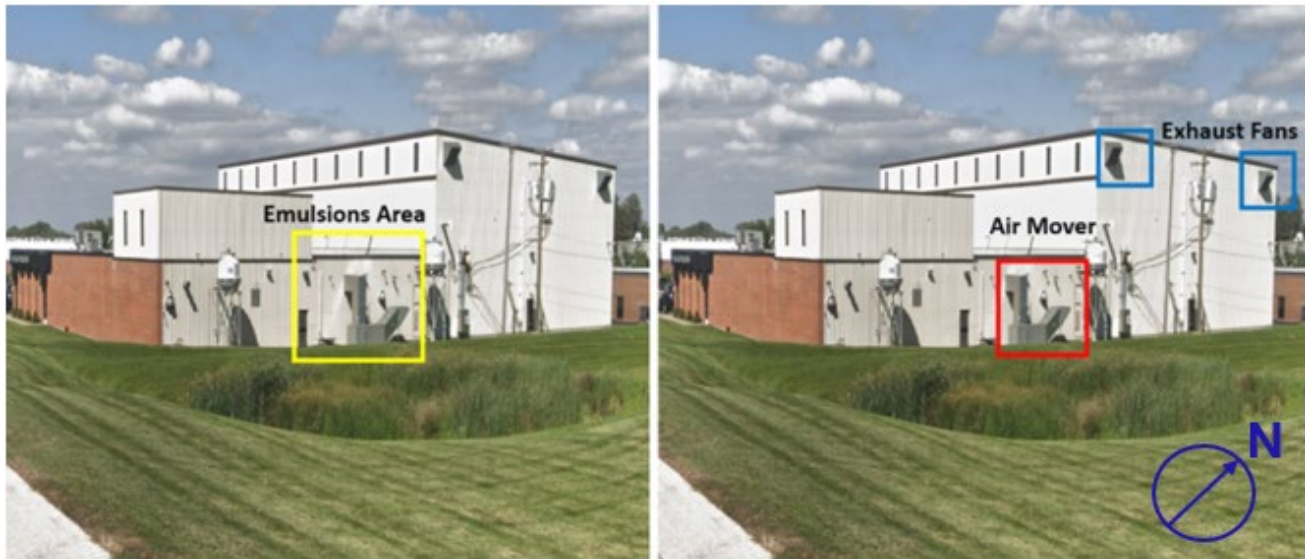
The Low Bay and the High Bay shared a mechanical ventilation system that consisted of air movers and exhaust fans throughout the building. In the production building emulsions area (where the incident occurred), there was one main air mover of 12,000 cubic feet per minute (CFM), as well as one smaller air mover, of 2,000 CFM, on the Low Bay roof. The main air mover provided approximately 86 percent of the total makeup air flow into the production building and could be operated manually. The Low Bay area had four 1,500 CFM roof exhaust fans,

two 1,500 CFM wall exhaust fans, and one 5,000 CFM roof exhaust fan that ran continuously. In addition, on the High Bay end, there were two exhaust fans with a total capacity of about 44,000 CFM. These exhaust fans did not run continuously and had to be manually activated by a switch located in the maintenance area. **Figure 6** shows the location of the emulsions area (yellow box), the main air mover (red box), and exhaust fans (blue boxes) visible on the side of the production building.

Figure 6. Location of the emulsions area and the ventilation system components. (Credit: Google Maps with annotations by CSB)

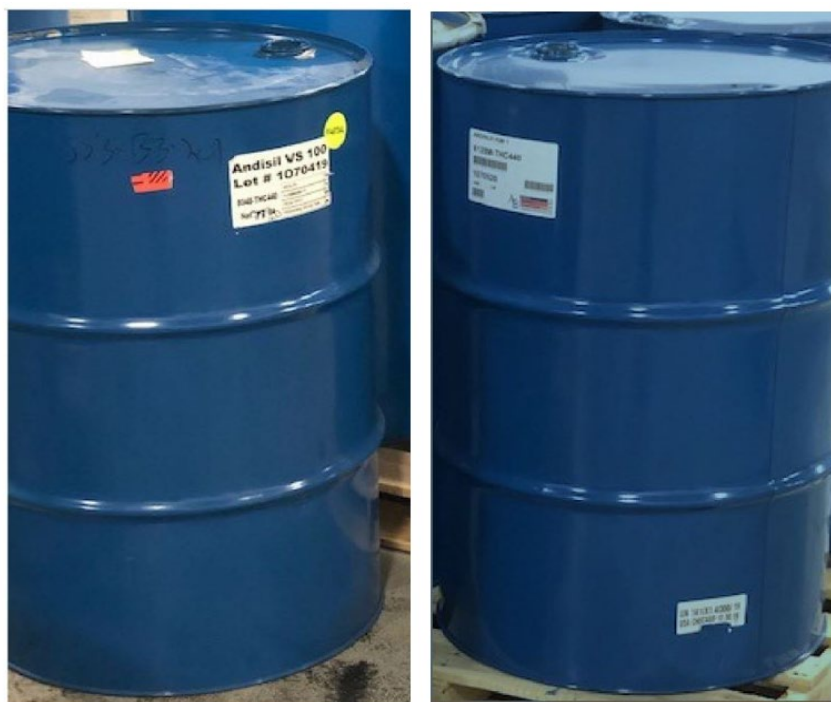
In March 2019 (about two months prior to this incident), AB Specialty experienced a near-miss event involving two chemicals stored in similar 55-gallon blue metal drums. In that event, an AB Specialty employee requested two drums of a chemical for use in a batch process. When the drums arrived in the process area, the employee looked at the affixed label on one of the drums and verified that it was the correct material. The employee then charged the material in that drum to the batch, and when that drum was empty, he began the process of charging the second drum to the batch. At that point, the employee looked at the label on the second drum and realized it was not the correct material. He immediately stopped the batch process and notified management. Aside from the printed text on the paper label, the two drums looked identical (**Figure 10**). AB Specialty logged this incident as a near miss, made the double initial practice a written procedure, and retrained all production employees. The procedure required that chemicals be verified by two employees, with those employees both initialing the batch ticket before charging chemicals to a batch.

Figure 10. Two chemicals in similar drums involved in previous near-miss incident. (Credit: AB Specialty)

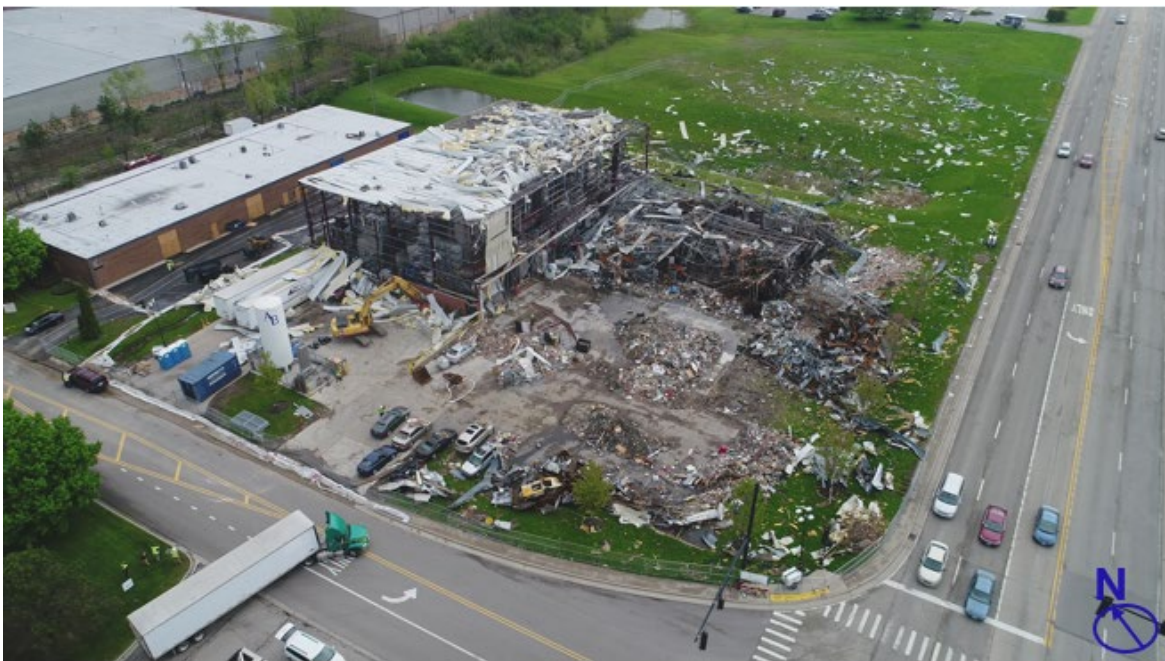
The building was destroyed by the explosion (**Figure 12**).^a Debris extended for several hundred feet from the building, and nearby business properties were also damaged. Four AB Specialty employees (Operator 1, Shift Supervisor 1, a shift supervisor for a separate shift, and a QC chemist) were fatally injured by the explosion, and Operator 3 was injured.

Figure 12. Post-explosion photo of the AB Specialty facility. (Credit: CSB)

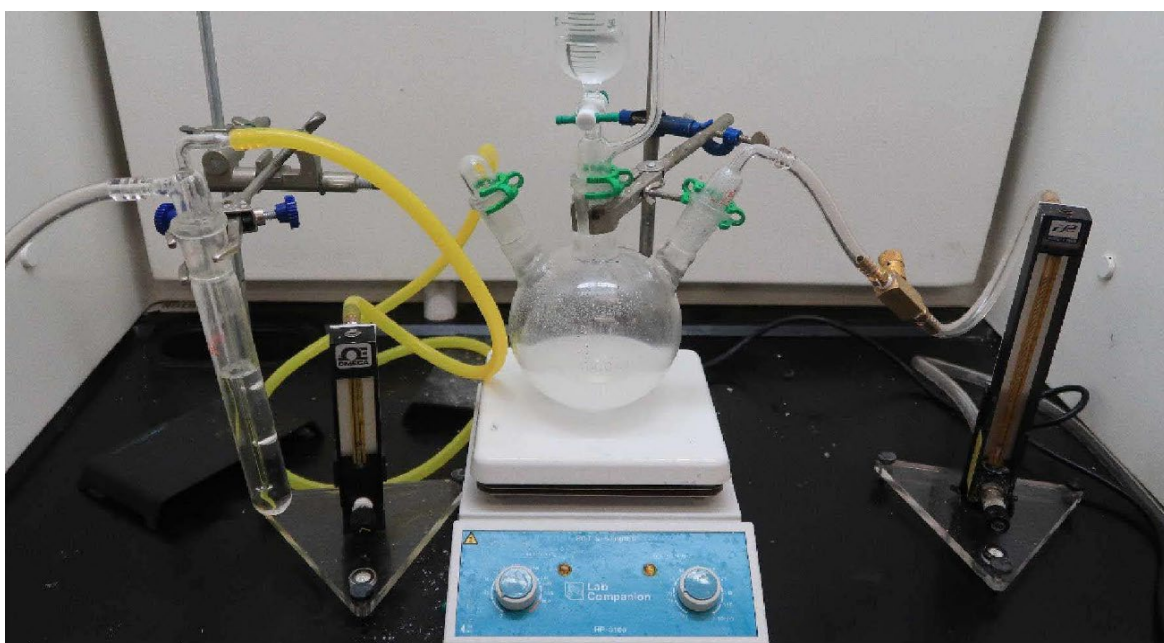
Figure C- 2. Closed system experimental setup – with Nitrogen and Flow Meter. (Credit: Crane)

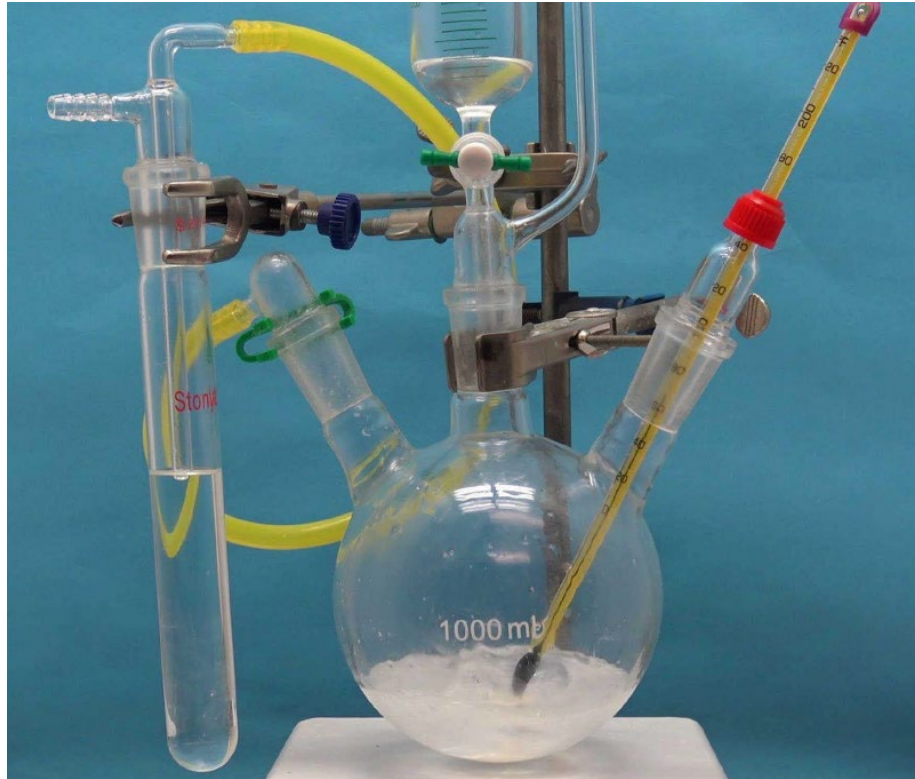
Figure C- 3. Closed system experimental setup – without Nitrogen and Flow Meter. (Credit: Crane)

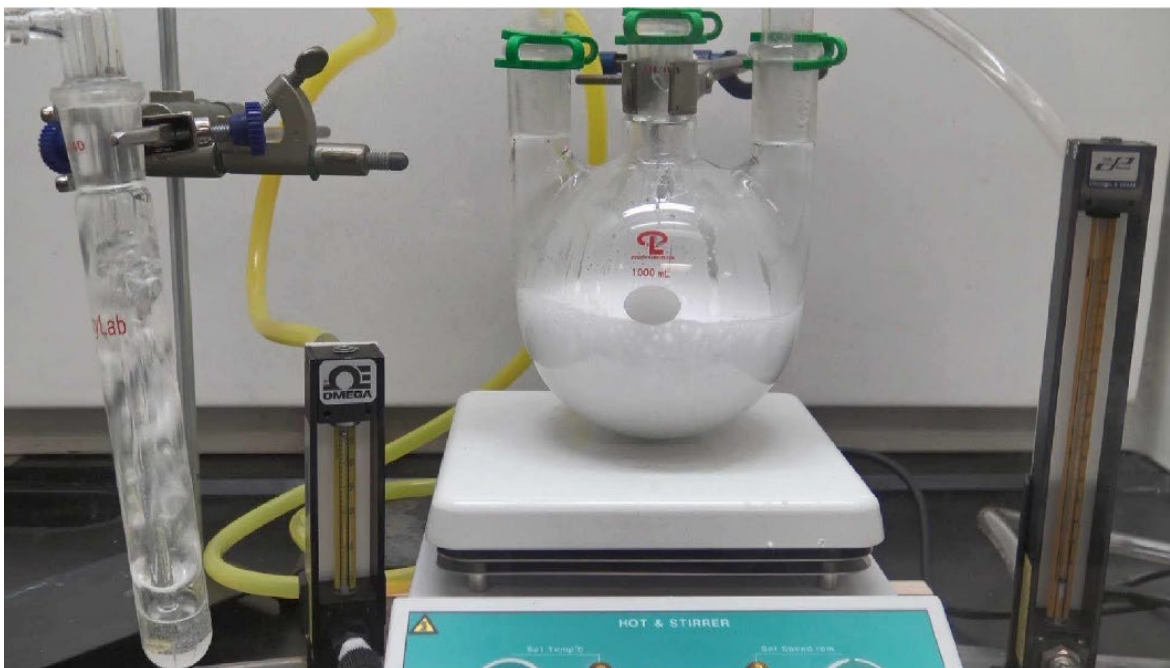
Figure C- 8. Photograph of TD-KOH test a few seconds before joint was blown off due to substantial gas generation. (Credit: Crane)
